SC-8636  
SC-8636

MCNAB-POTLATCH 7.03km

2022 Inspection

Structure Class Major Culvert

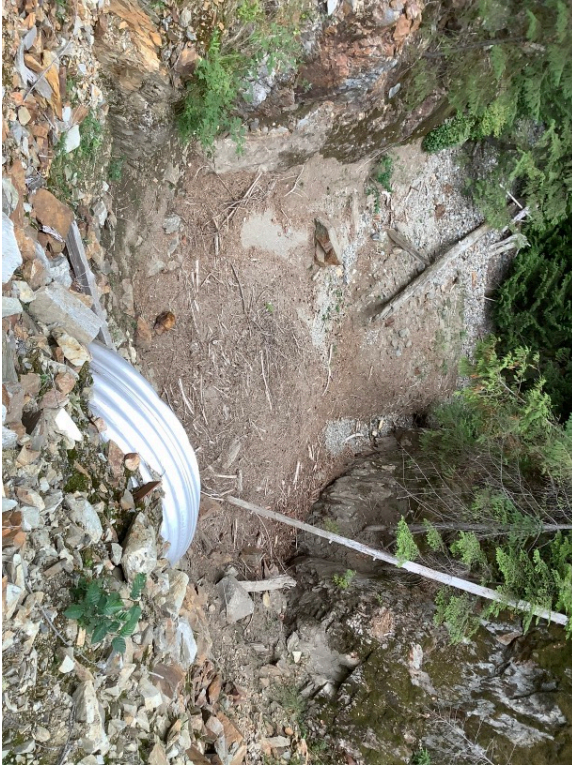
Large channel. No change since last inspection. Evidence of significant past bed load movement in channel. Monitor bedload at inlet.

Inlet Good Sump at inlet
