SC-8642  
SC-8642

## SECHELT CREEK 7.41km

2022 Inspection

Structure Class Temporary Bridge

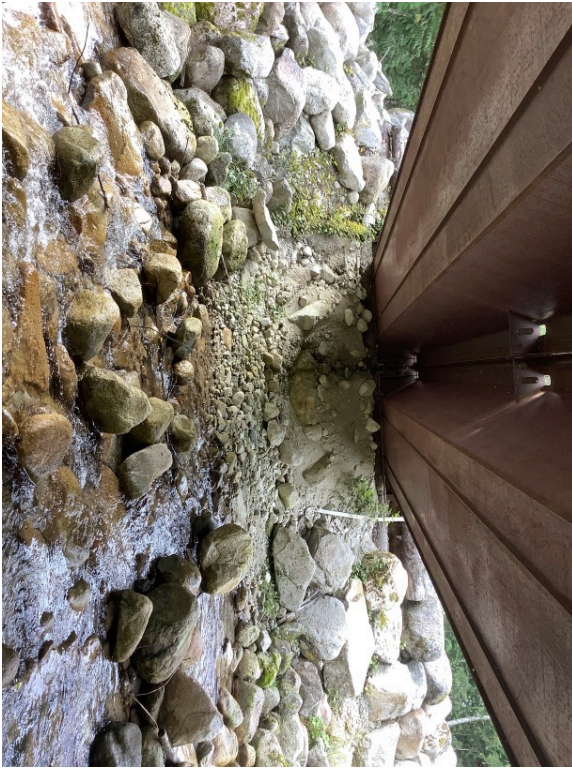
Left Bank Abutment when facing downstream

Caps or Sills **Fair** Fir sills. Starting to show signs of rot

Hardware **Poor** Bolts on sills loose

Consider replacing sills. Monitor during active industrial use

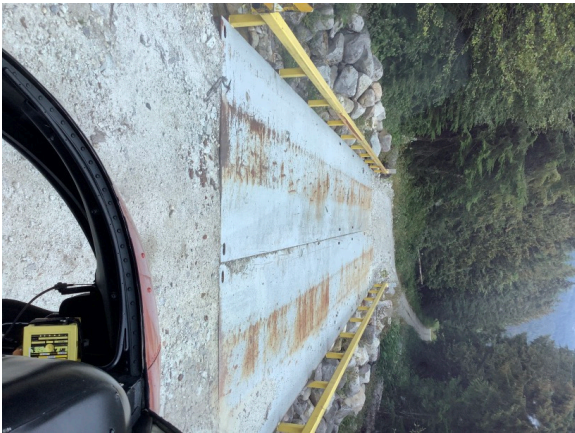
Overall Deck Condition      **Good**
