SC-8644  
SC-8644

BRITAIN RIVER 4.82km

2022 Inspection

Structure Class Major Culvert

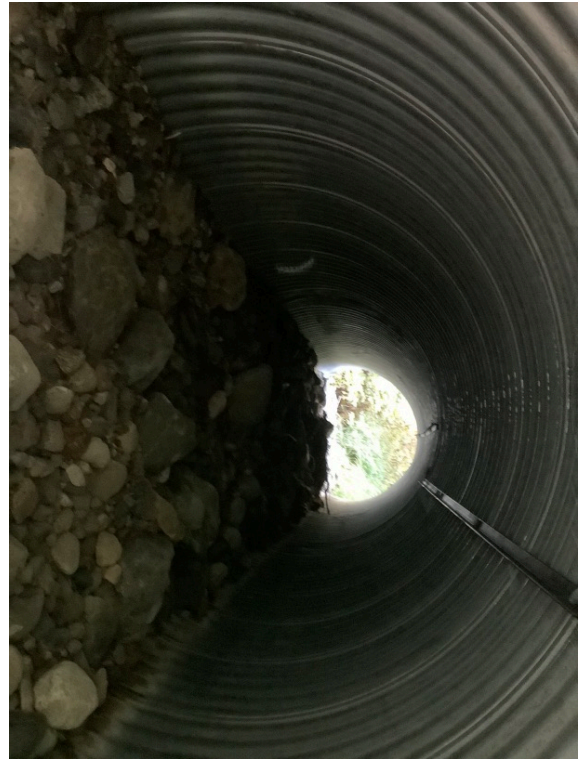
Inlet Good

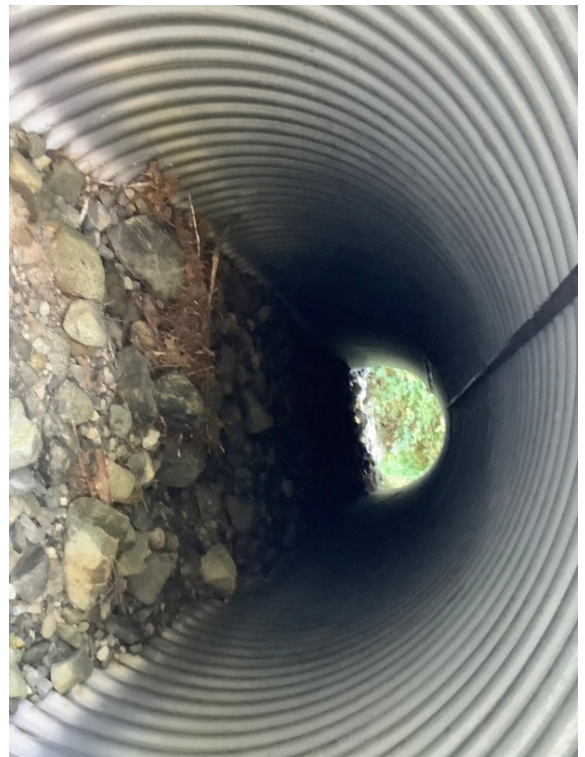
Outlet Good
