SC-8645  
SC-8645

BRITAIN RIVER 5.31km

2022 Inspection

Road Name BRITAIN RIVER

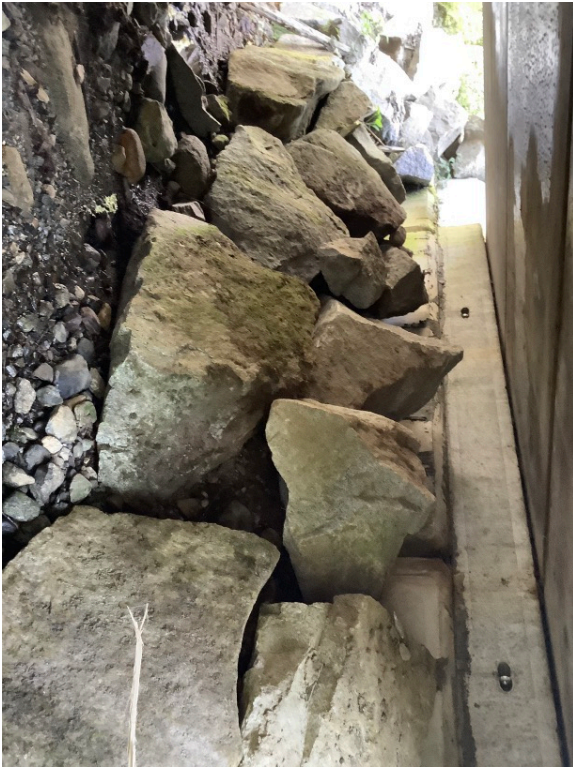
Right Bank Abutment when facing downstream

Concrete **Good**

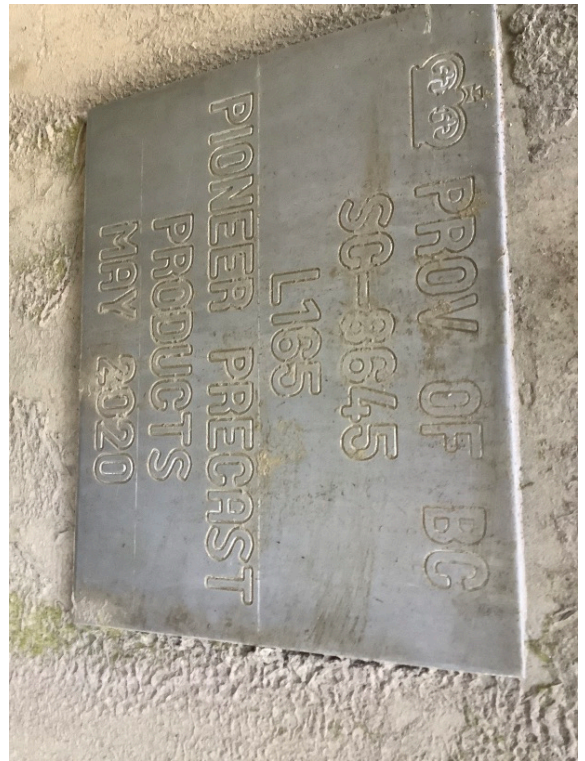
Structure ID

Inspector Comments Serial/ID Plate SC-8645

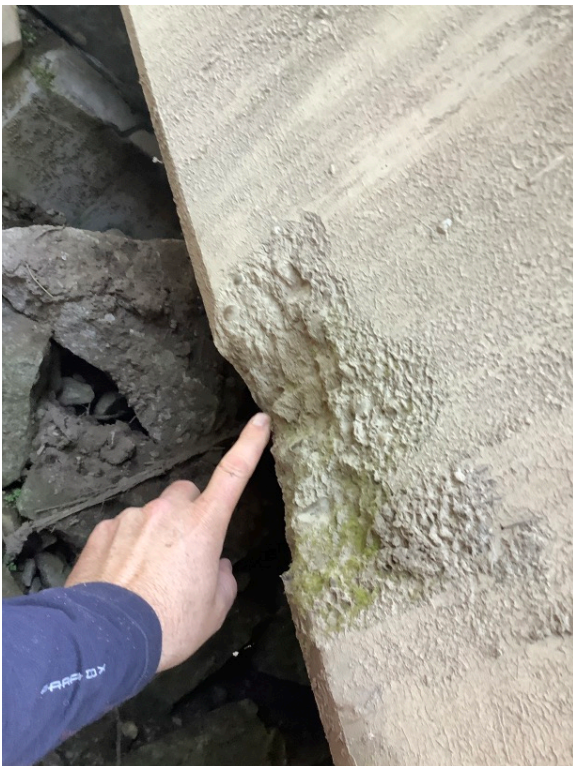
Upstream girder

Located where 8649 is on map. Minor chip in concrete , upstream side. No rebar showing.

Minor damage upstream girder

| Repair Item | Repair Description |
|---|---|
| 1 Structure. Concrete structural maintenance. m².<br>Priority:Low | Consider patching upstream girder concrete chip |
