SC-8646  
SC-8646

## BRITAIN RIVER 6.23km

2022 Inspection

Structure Class Major Culvert

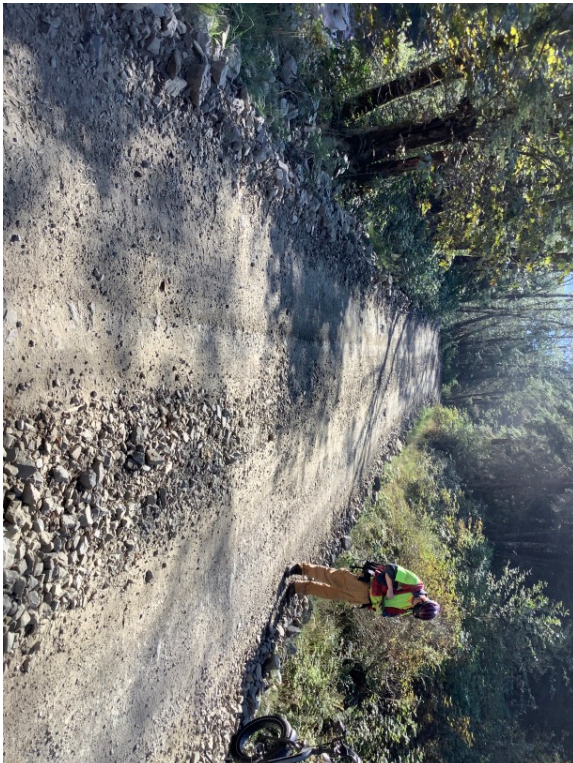
Approach from Right Bank when facing downstream
