SC-8647  
SC-8647

BRITAIN RIVER 6.97km

2022 Inspection

Load Rated by: Richard Mills, P.Eng. Jan 30, 2023  
Load Rating: L165 or 150 tonnes  
Next Inspection: 2025

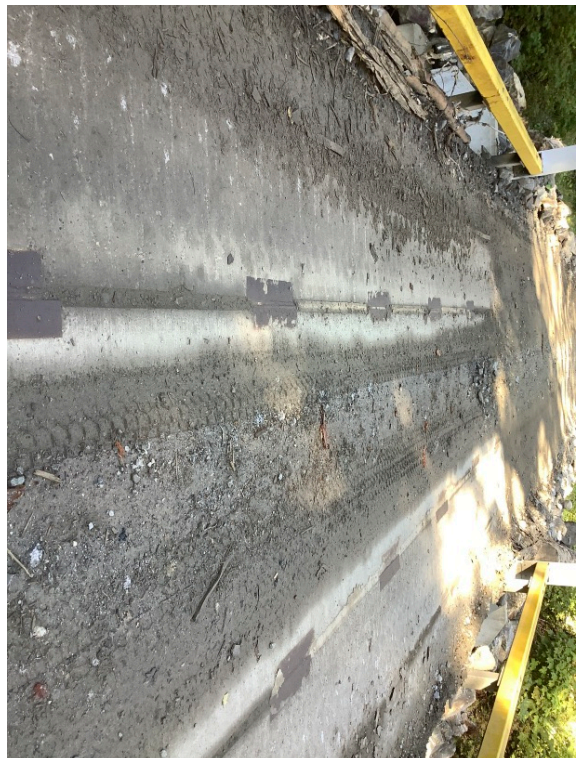
Overall Deck Condition      **Good**

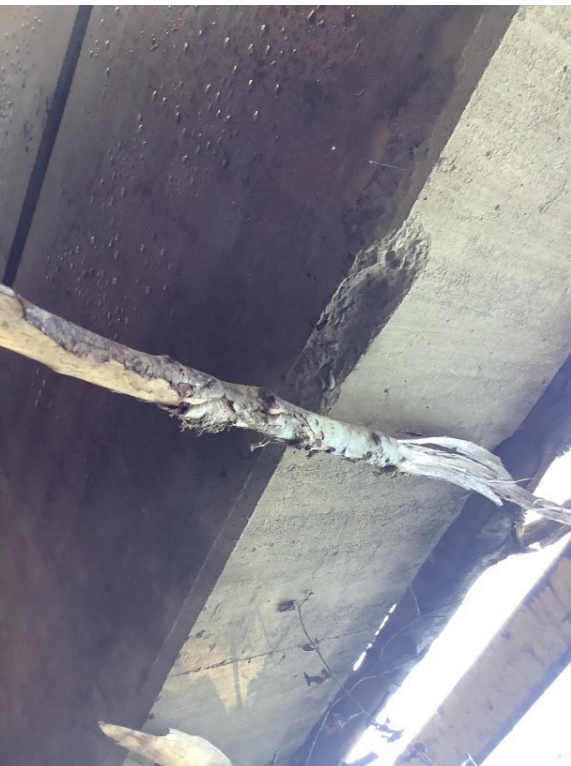
Girders Good Minor chip upstream girder.

Minor chip upstream girder
