SC-8649  
SC-8649

## BRITAIN RIVER 7.1km

2022 Inspection

Structure Class Major Culvert

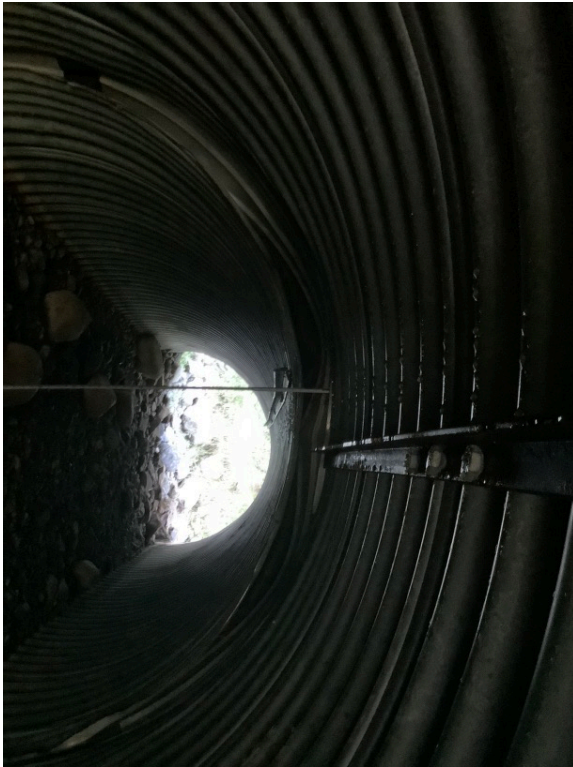
Culvert coupler

| Coupled Connections | Fair | 100mm gap at couple roof. Coupler is dented. Pipes seem ok. Monitor. |

| Item | Monitor Description | Frequency |
|---|---|---|
| 1 | Monitor coupler | Routine Inspection |

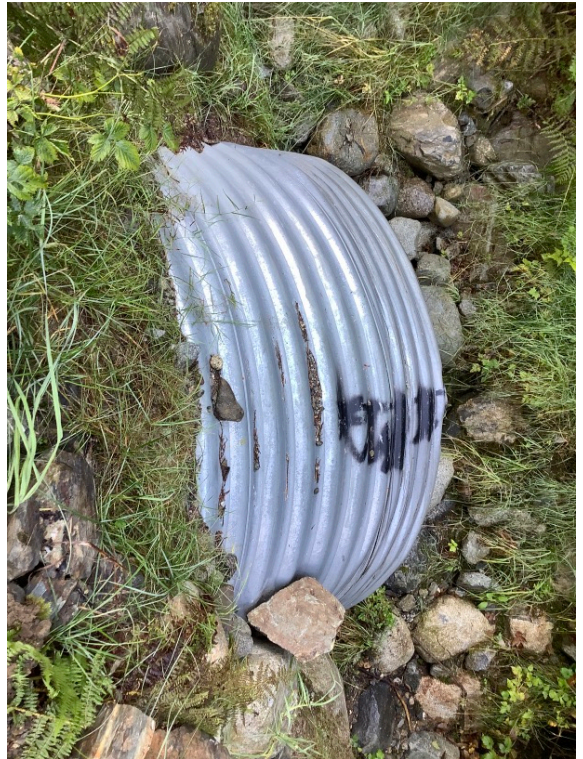
| Inlet | Good | |
