SC-8651  
SC-8651

BRITAIN RIVER 7.71km

2022 Inspection

Structure Class Permanent Bridge

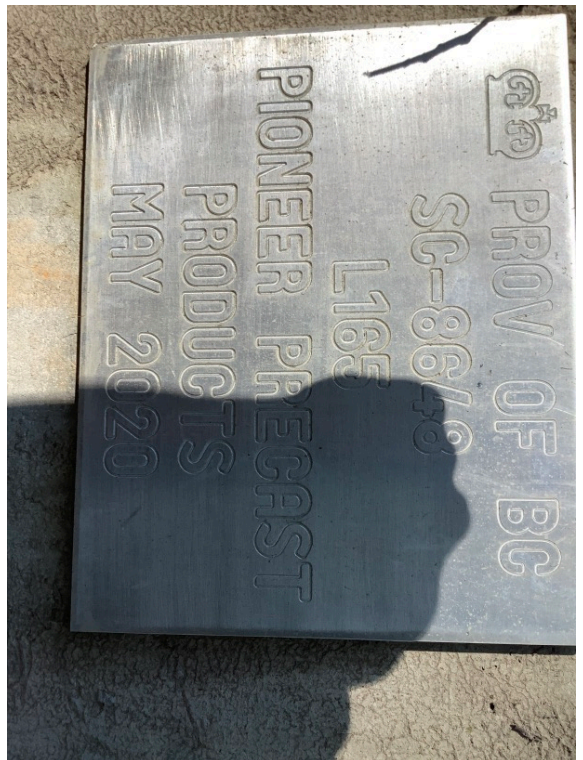
Structure ID

Load Rated by: Richard Mills, P.Eng. Feb 8, 2023  
Load Rating: L165 or 150 tonnes  
Next Inspection: 2025  
Comments: Structure tag is for SC-8648. Confirm that this site is SC-8651.

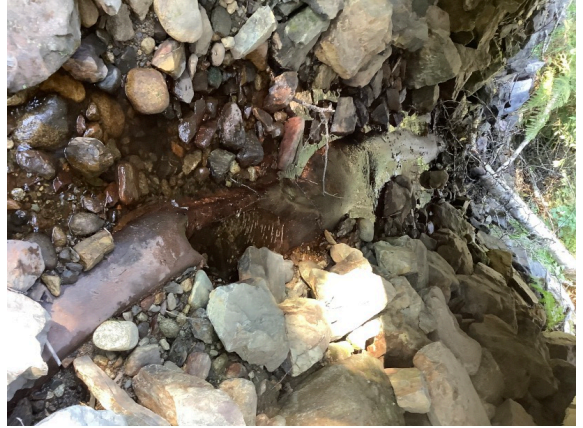
Old boiler culvert left in place
