SC-8655  
SC-8655

LOIS 9.83km

2022 Inspection

Structure Class Major Culvert

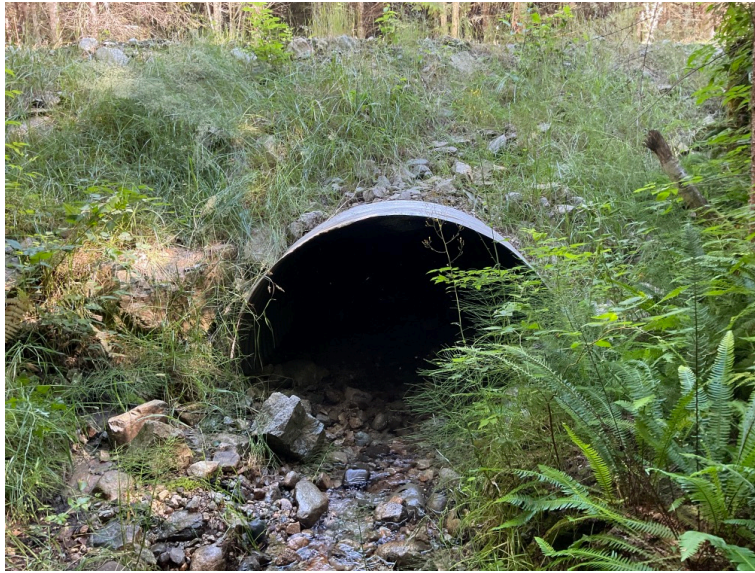
Inlet      Good

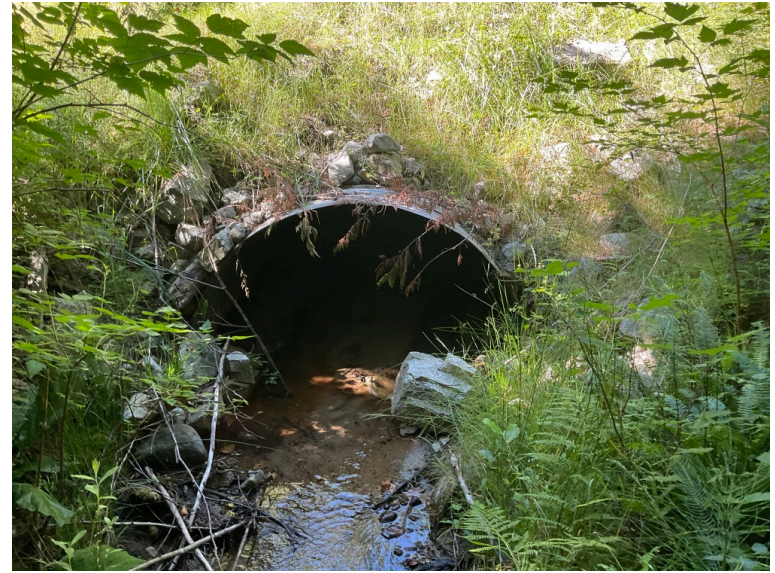
Outlet      Good

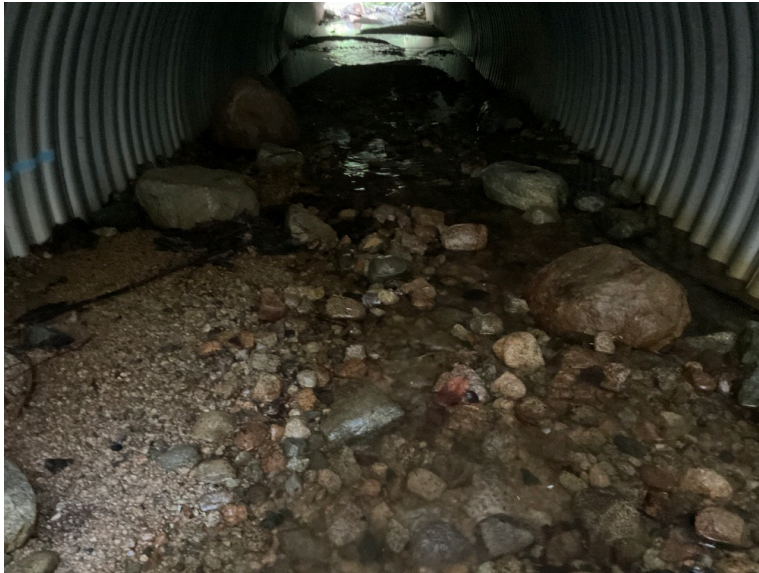
Culvert Floor

Floor      Good

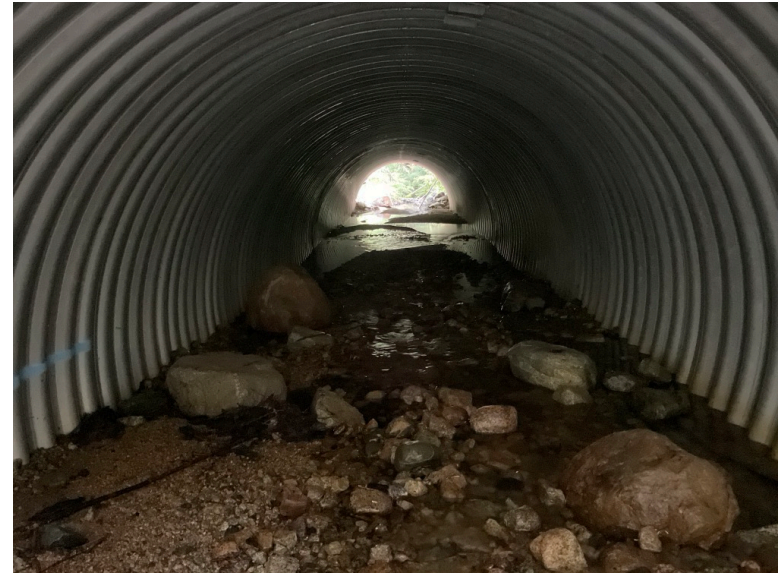
Looking Downstream Through CMP

Embedment Materials      Good      Some material has migrated Downstream approx 10cm
