SC-8656  
SC-8656

LOIS 9.89km

2022 Inspection

Structure Class Major Culvert

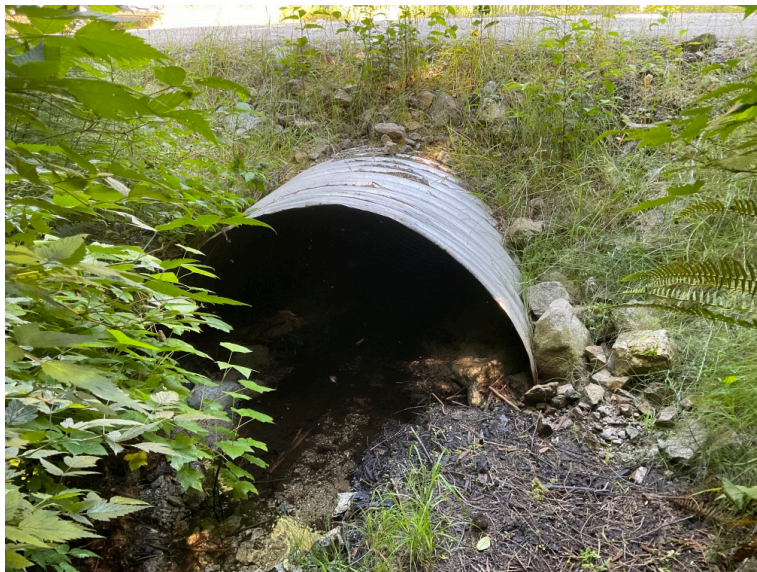
Inlet      Good

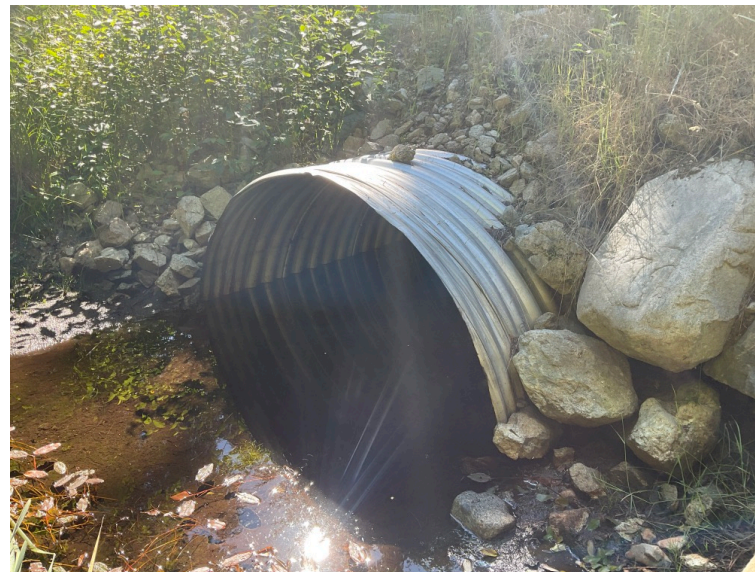
Outlet      Good

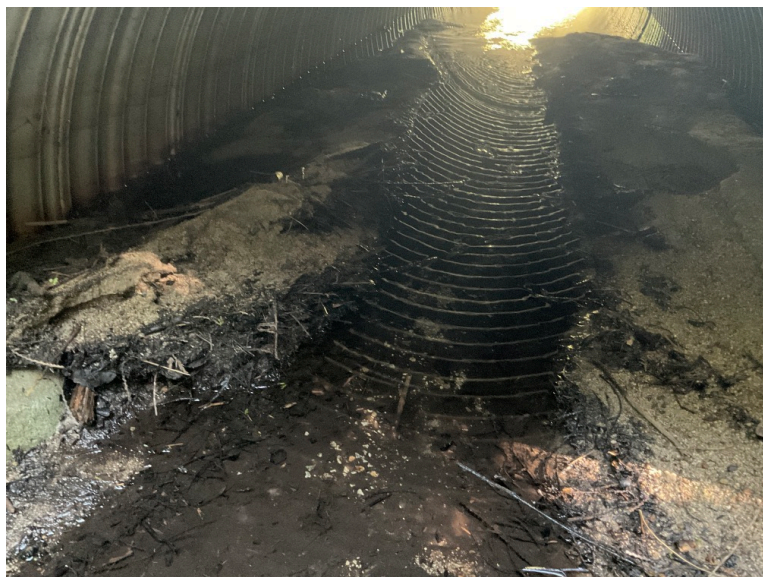
Culvert Floor

Floor      Good
