SC-8660  
PC-082

RAINY RIVER 0.78km

2022 Inspection

Crossing Name Stream 8

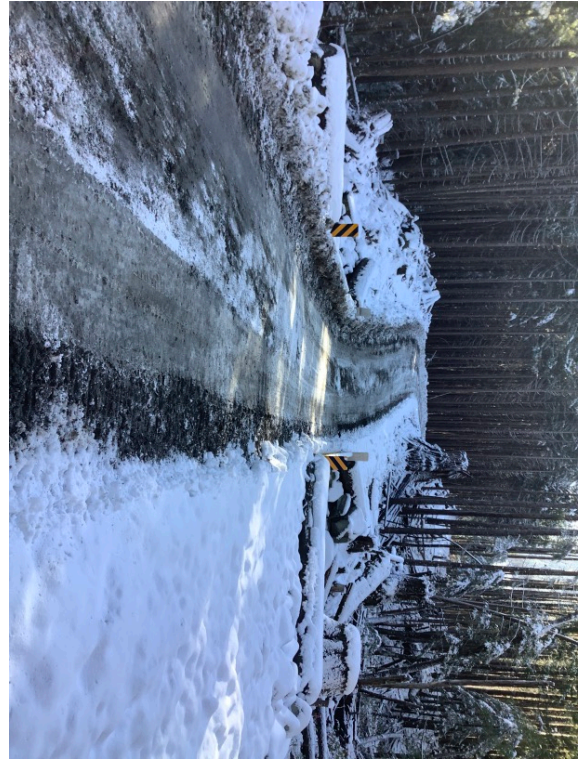
Approach from Left Bank when facing downstream

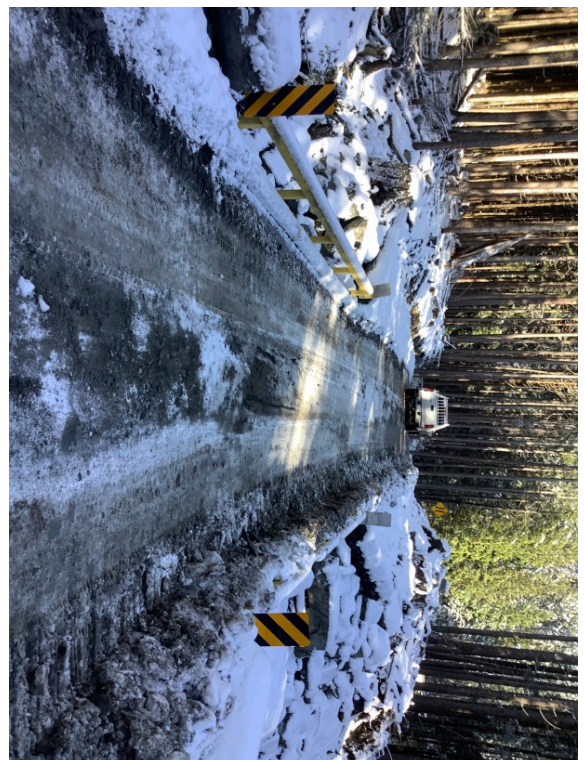
Approach from Right Bank when facing downstream

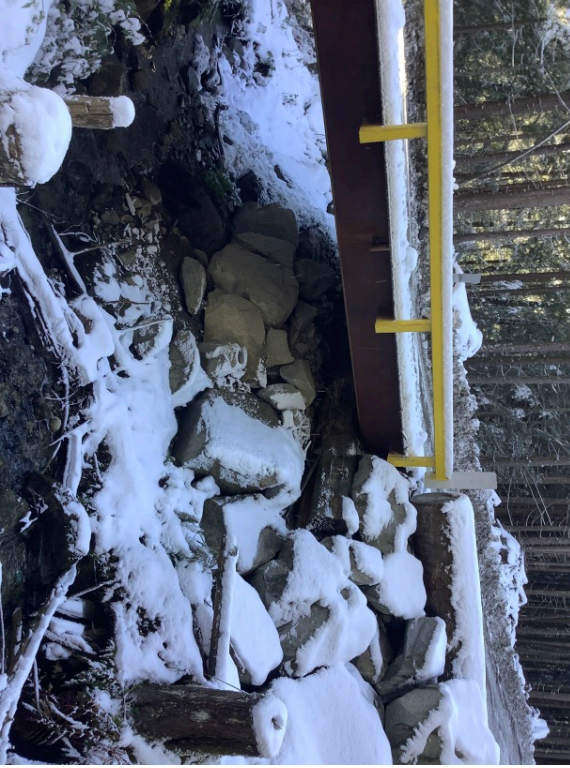
Right Bank Abutment when facing downstream

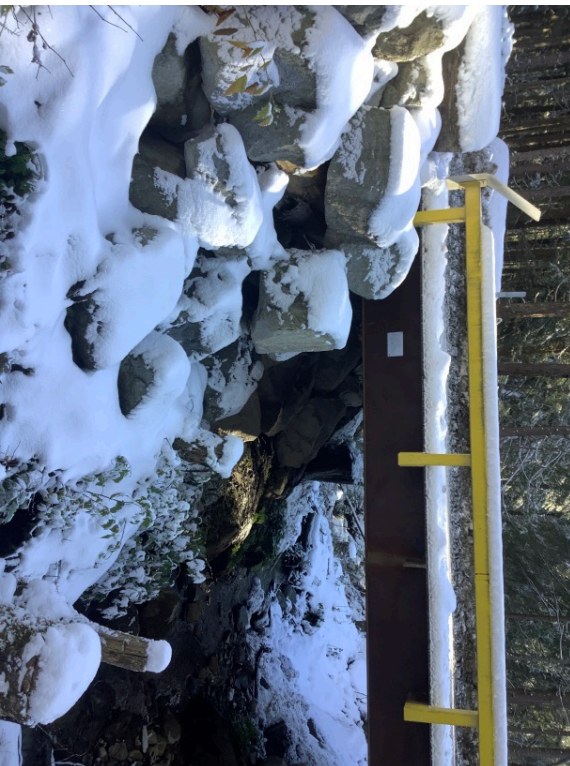
Left Bank Abutment when facing downstream
