SC-8662  
SC-8662

RAINY RIVER 0.66km

2022 Inspection

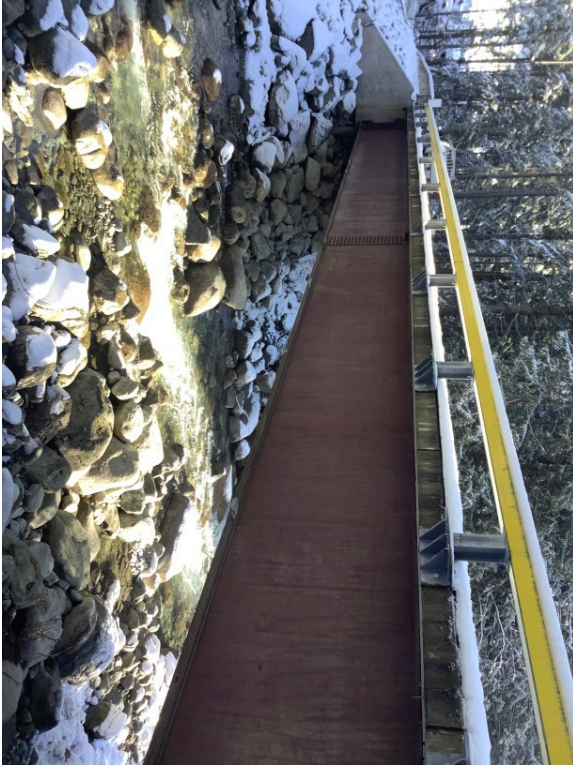
Approach from Left Bank when facing downstream

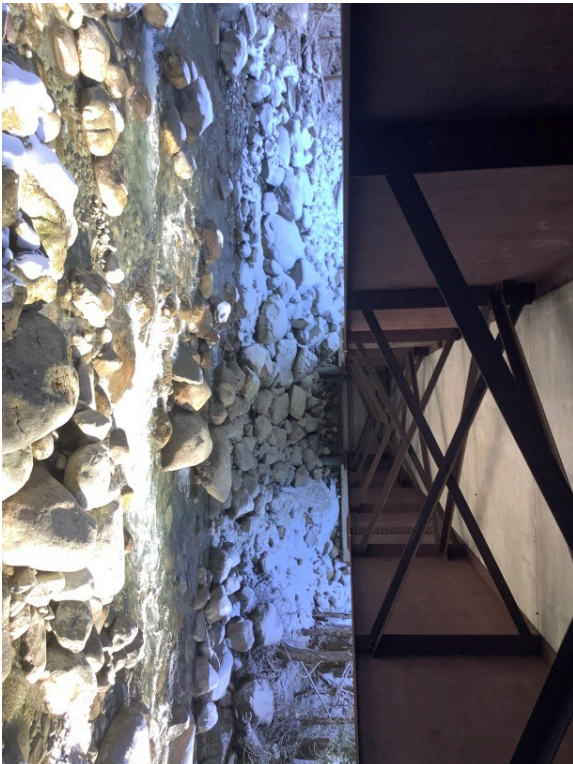
Left Bank Abutment when facing downstream
