Sc-8663  
Sc-8663

Britain River 10.9km

2022 Inspection

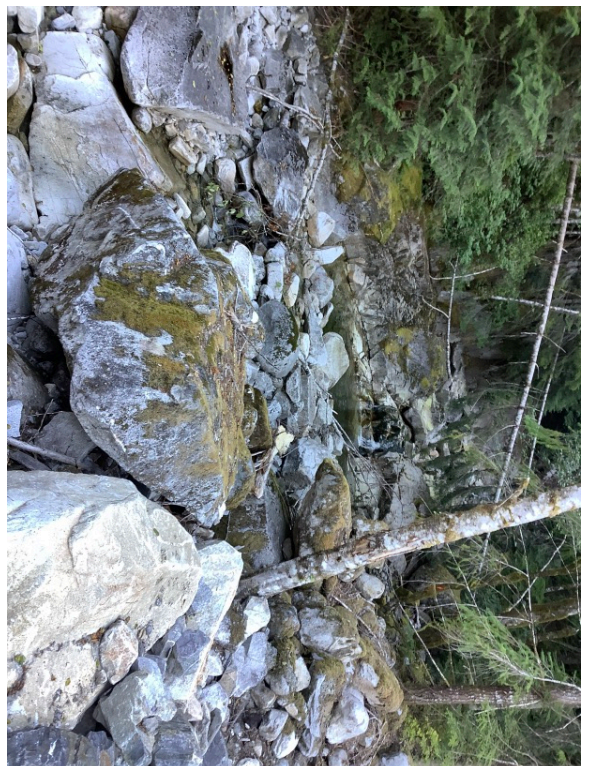
Upstream Profile

May be susceptible to high water events. Flat top lock blocks and pad footings nearby. May not have been used on bridge.

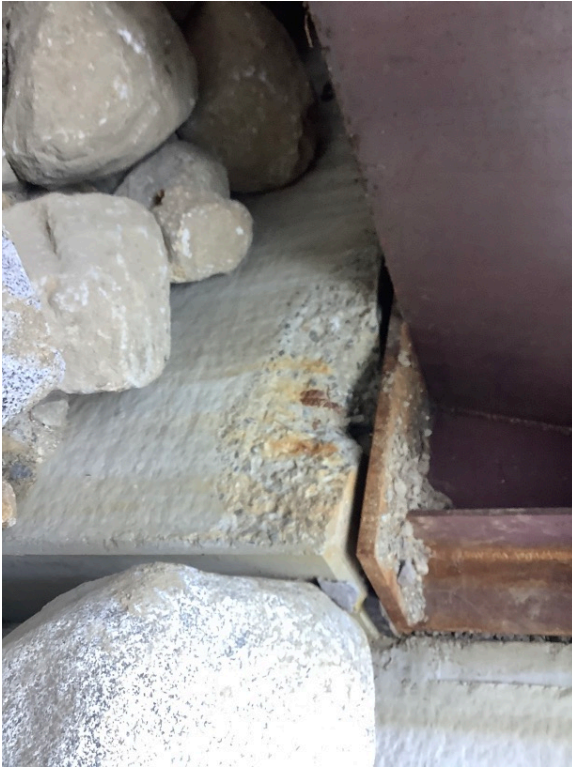
Left Bank Abutment when facing downstream

Sills chipped both sides. Minor. Rebar showing, consider patching.

| Repair Item | Repair Description |
|---|---|
| 1 Structure. Concrete structural maintenance. m². Priority:Low | Consider patching upstream side concrete sills. 30x30cm area. |

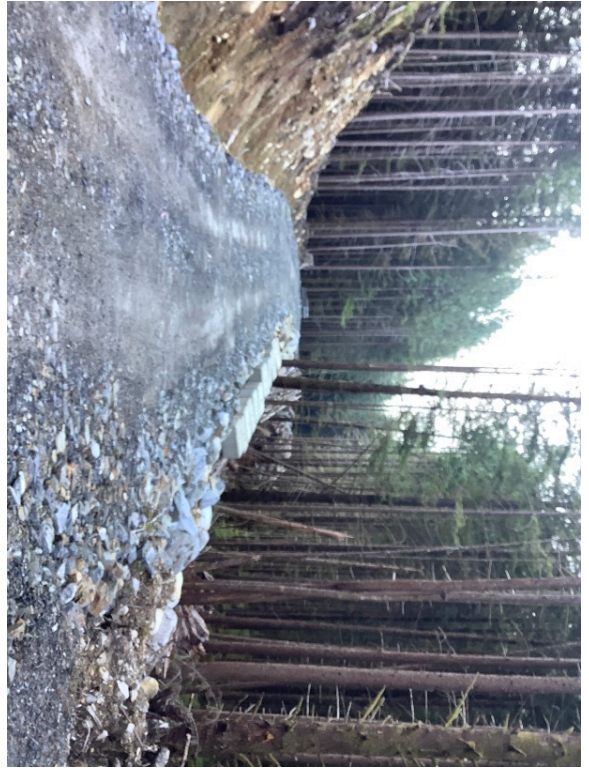
Flat lock blocks, and pads nearby.

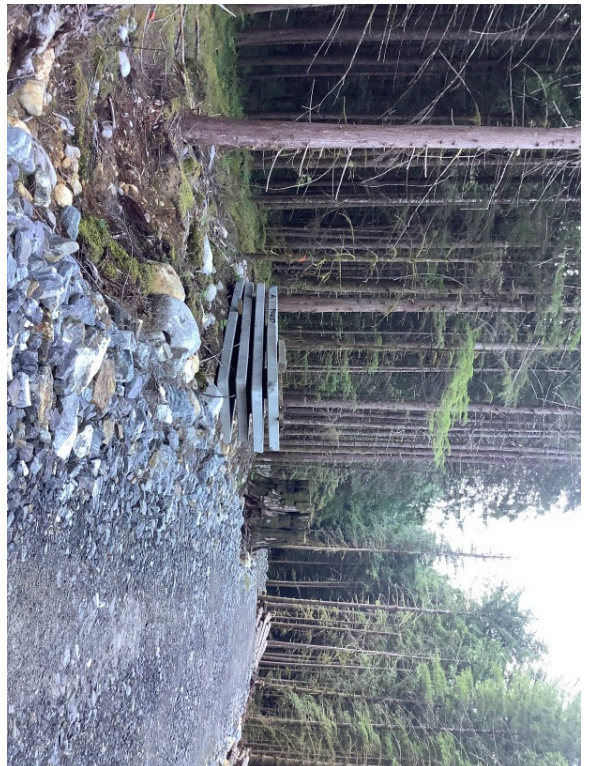
Nearby footings
