SQ-3002

STAWAMUS-INDIAN MAIN 3.6km

2019 Inspection

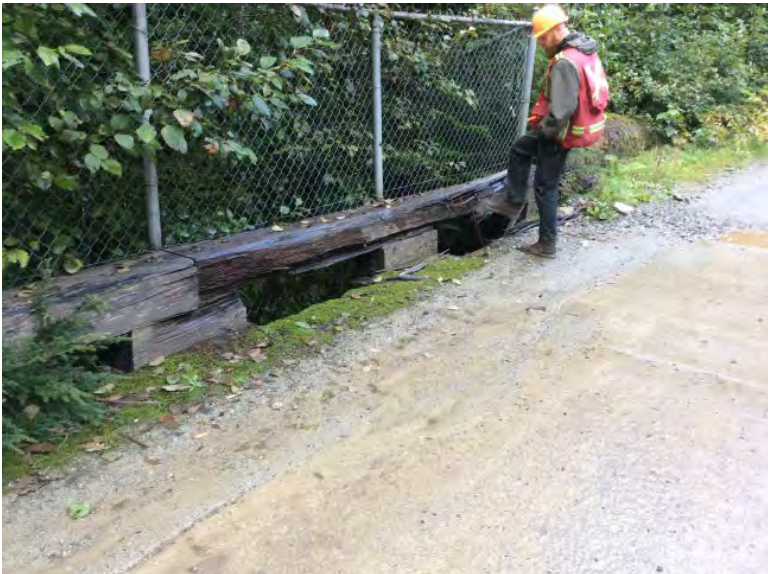
Guard Rail

Curb Rail/Blocks/Posts Poor Guard rail rotten and broken at woods end curb rails replaced  
Curbs need replacing prior to industrial use

| Item | Priority | Repair Description |
|---|---|---|
| 1 | High | Guard rail rotten and broken at woods end curb rails replaced<br>Curbs need replacing prior to industrial use |

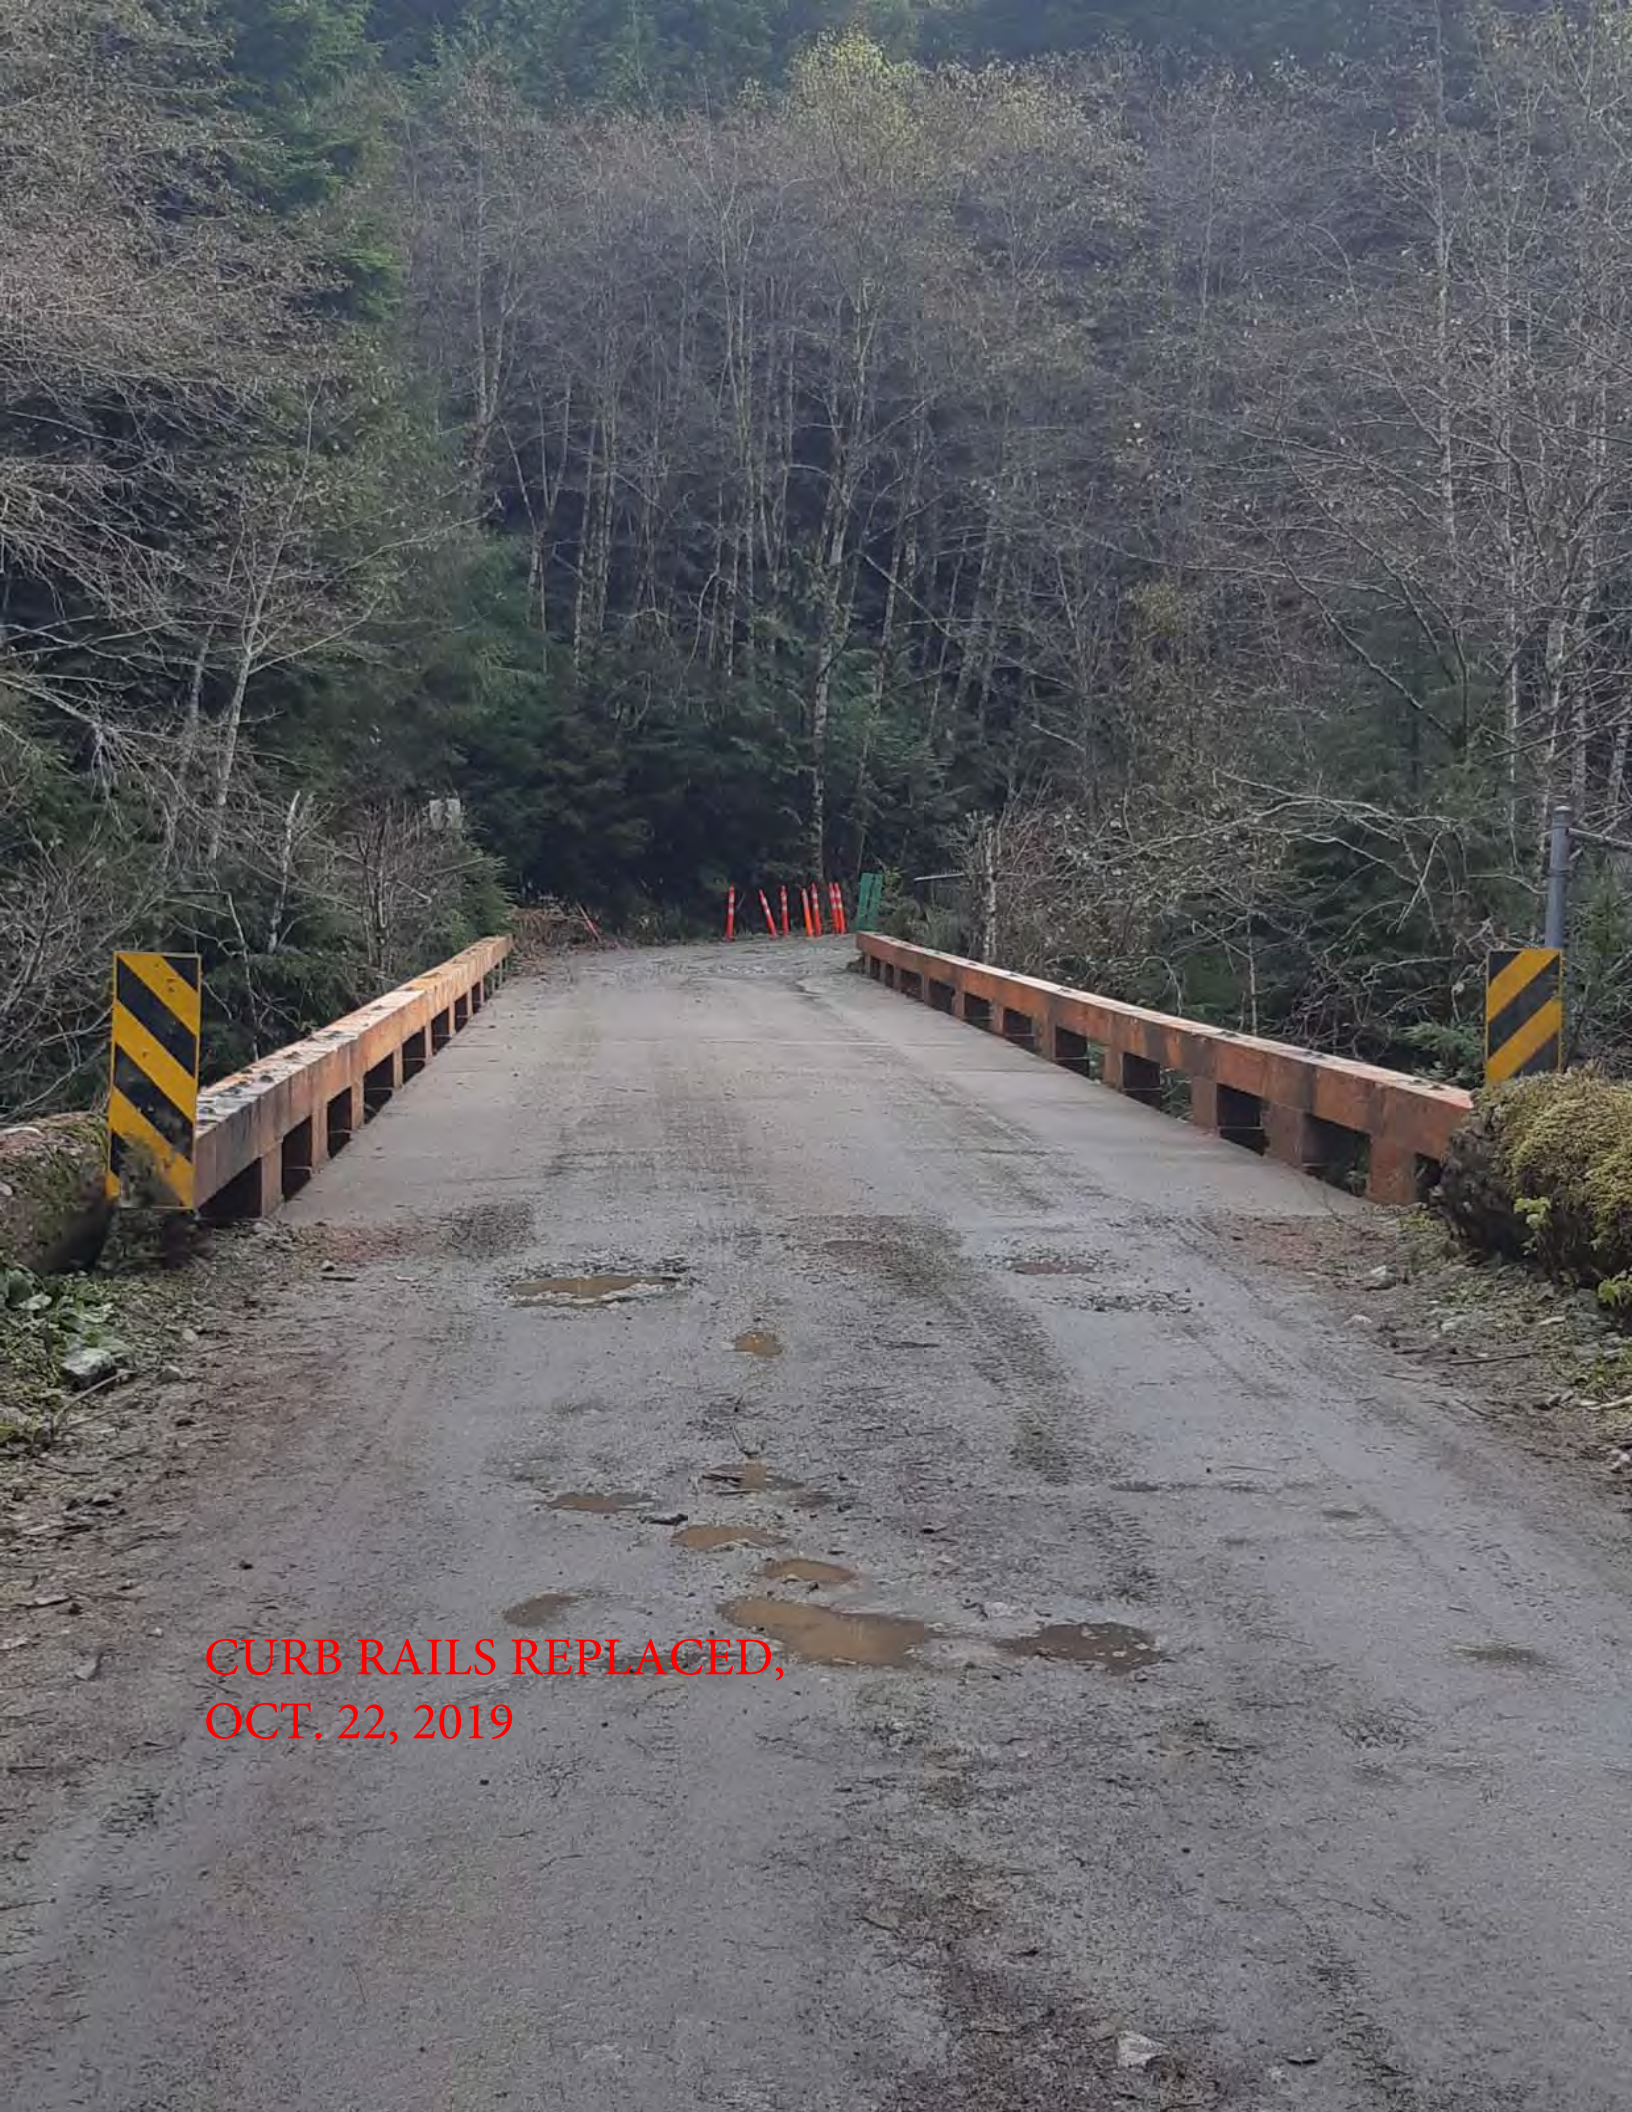
CURB RAILS REPLACED,  
OCT. 22, 2019

Load Rated by: MFLNRORD, Greg Dohm, PEng., Jan. 24, 2020  
Load Rating: L75 or 68 tonnes  
Next Inspection: 2022  
Comments: Curb rails found to require replacement. Curb rails were subsequently replaced in October 2019.
