SQ-3005

STAWAMUS-INDIAN MAIN

2019 Inspection

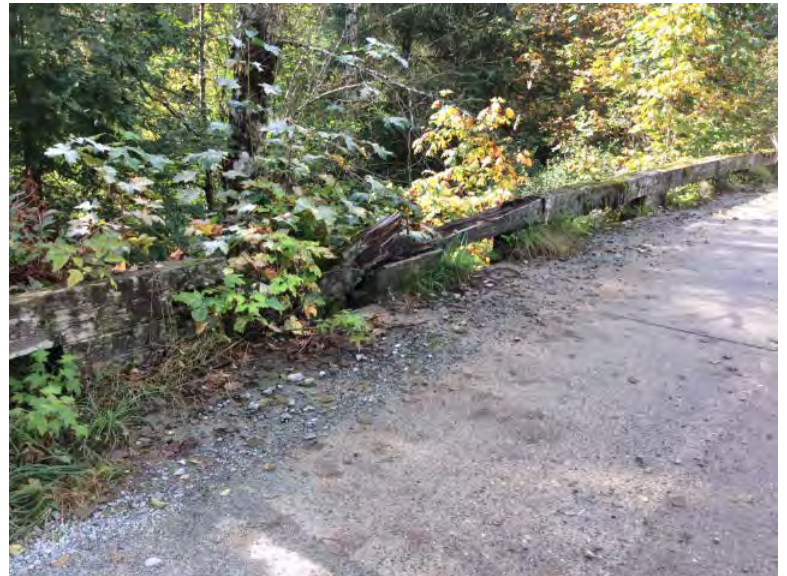
Guard Rail

Curb Rail/Blocks/Posts Poor Curb rails rotten and missing

| Item | Priority | Repair Description |
|---|---|---|
| 1 | High | Bridge closed for industrial use until rotten and missing curb rails replaced |
