SQ-3006

STAWAMUS-INDIAN MAIN

2019 Inspection

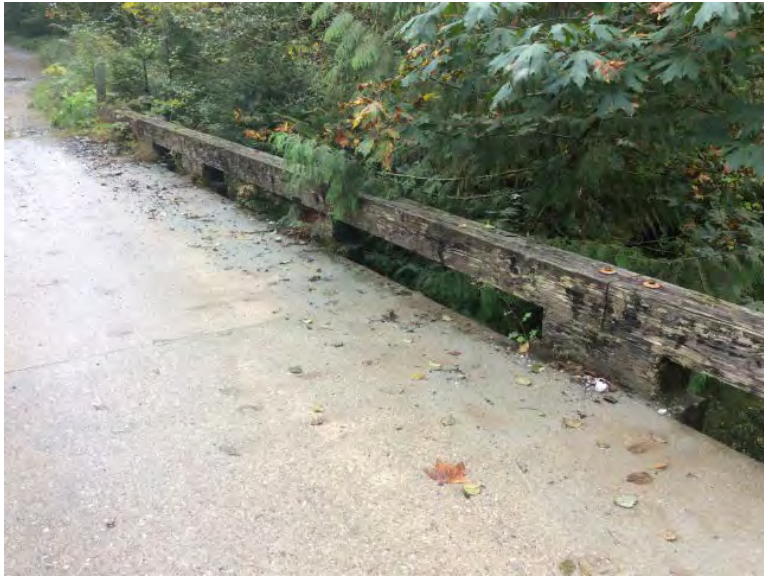
Guard Rail

Curbs need replacing prior to industrial use

Curb Rail/Blocks/Posts Poor Curbs need replacing prior to industrial use

Load Rated by: MFLNRORD, Greg Dohm, PEng., Jan. 22, 2020  
Load Rating: L120 or 109 tonnes  
Next Inspection: 2020  
Comments: Curb rails found to require replacement. Curb rails were subsequently replaced in October 2019.

| Repair Item | Priority | Repair Description |
|---|---|---|
| 1 | High | Curbs need replacing prior to industrial use |

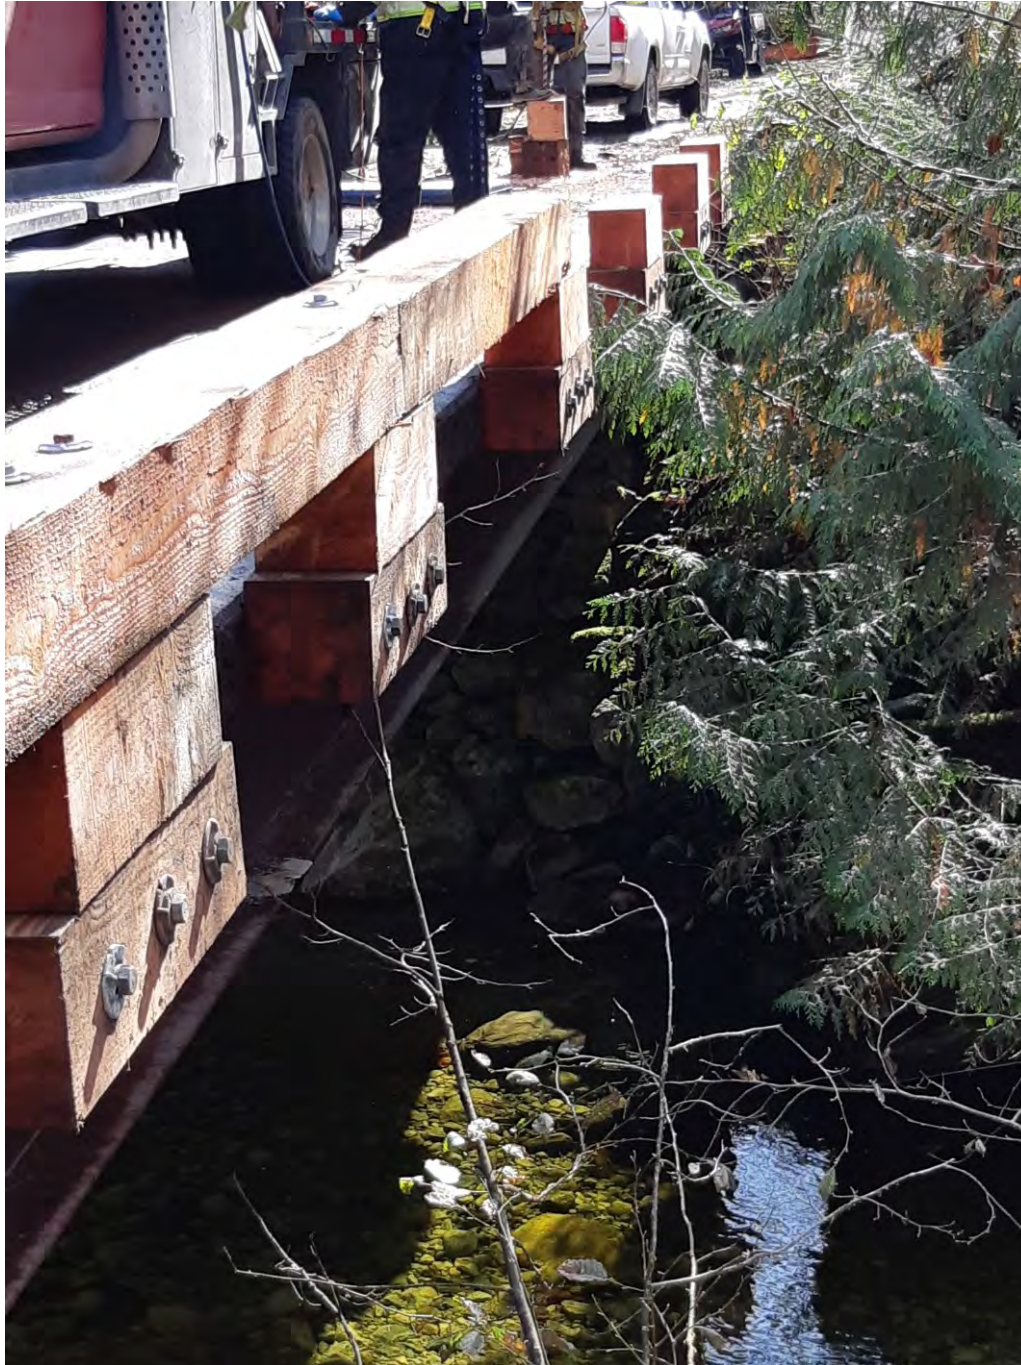
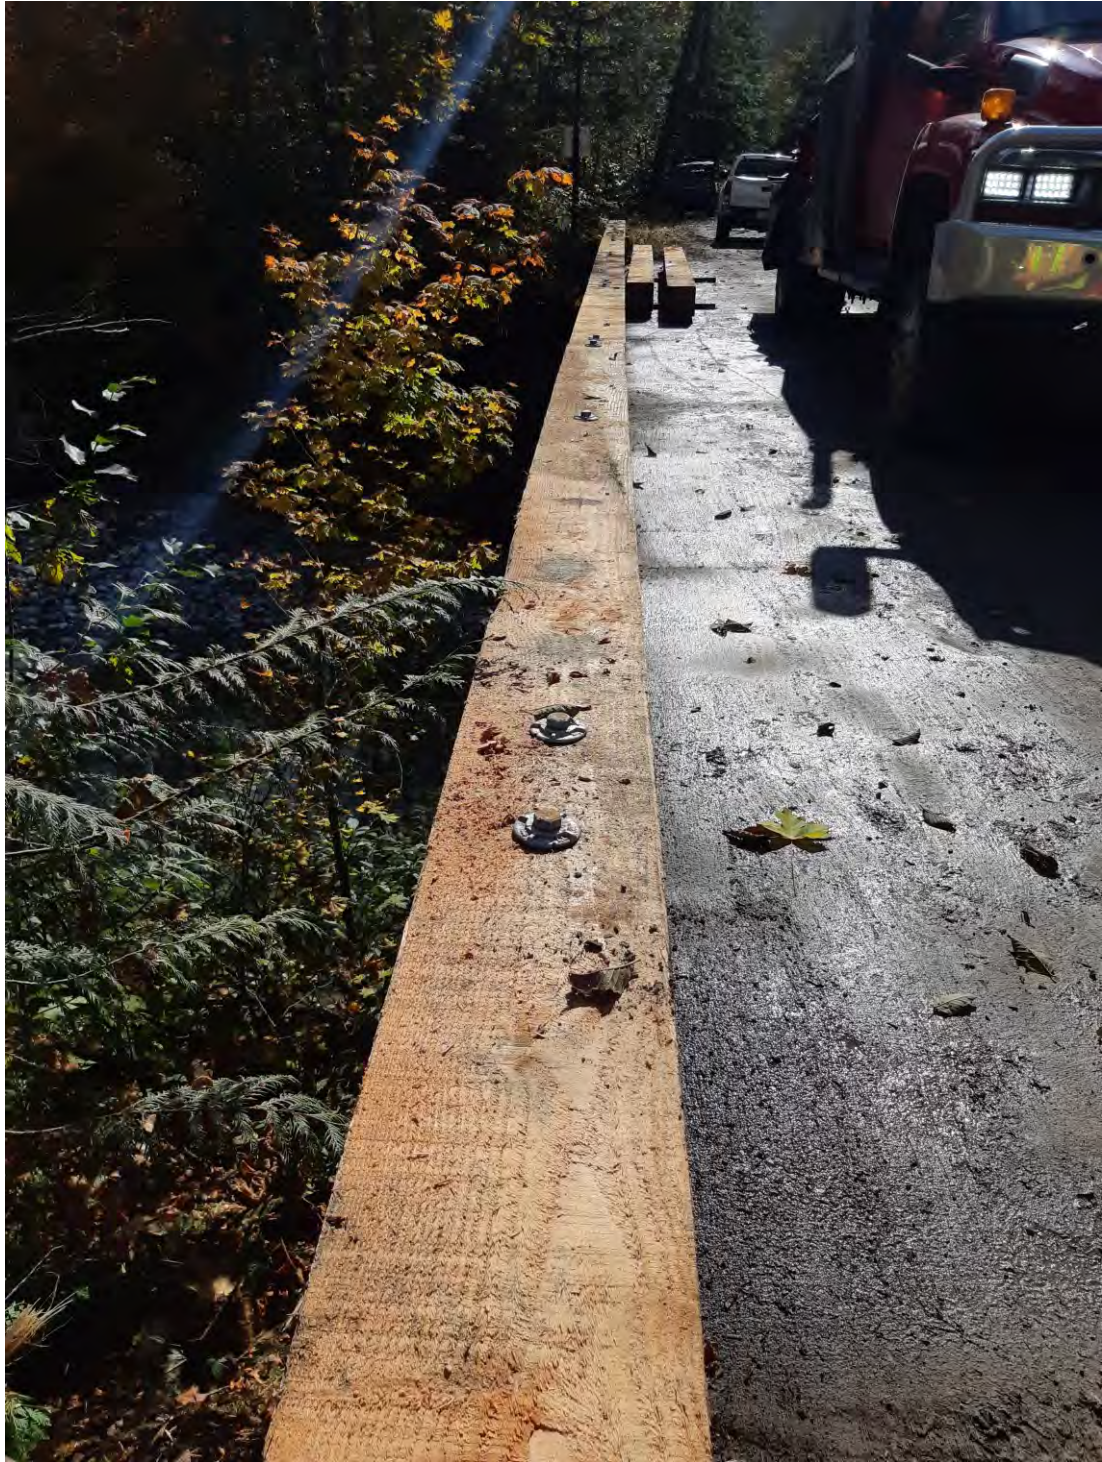
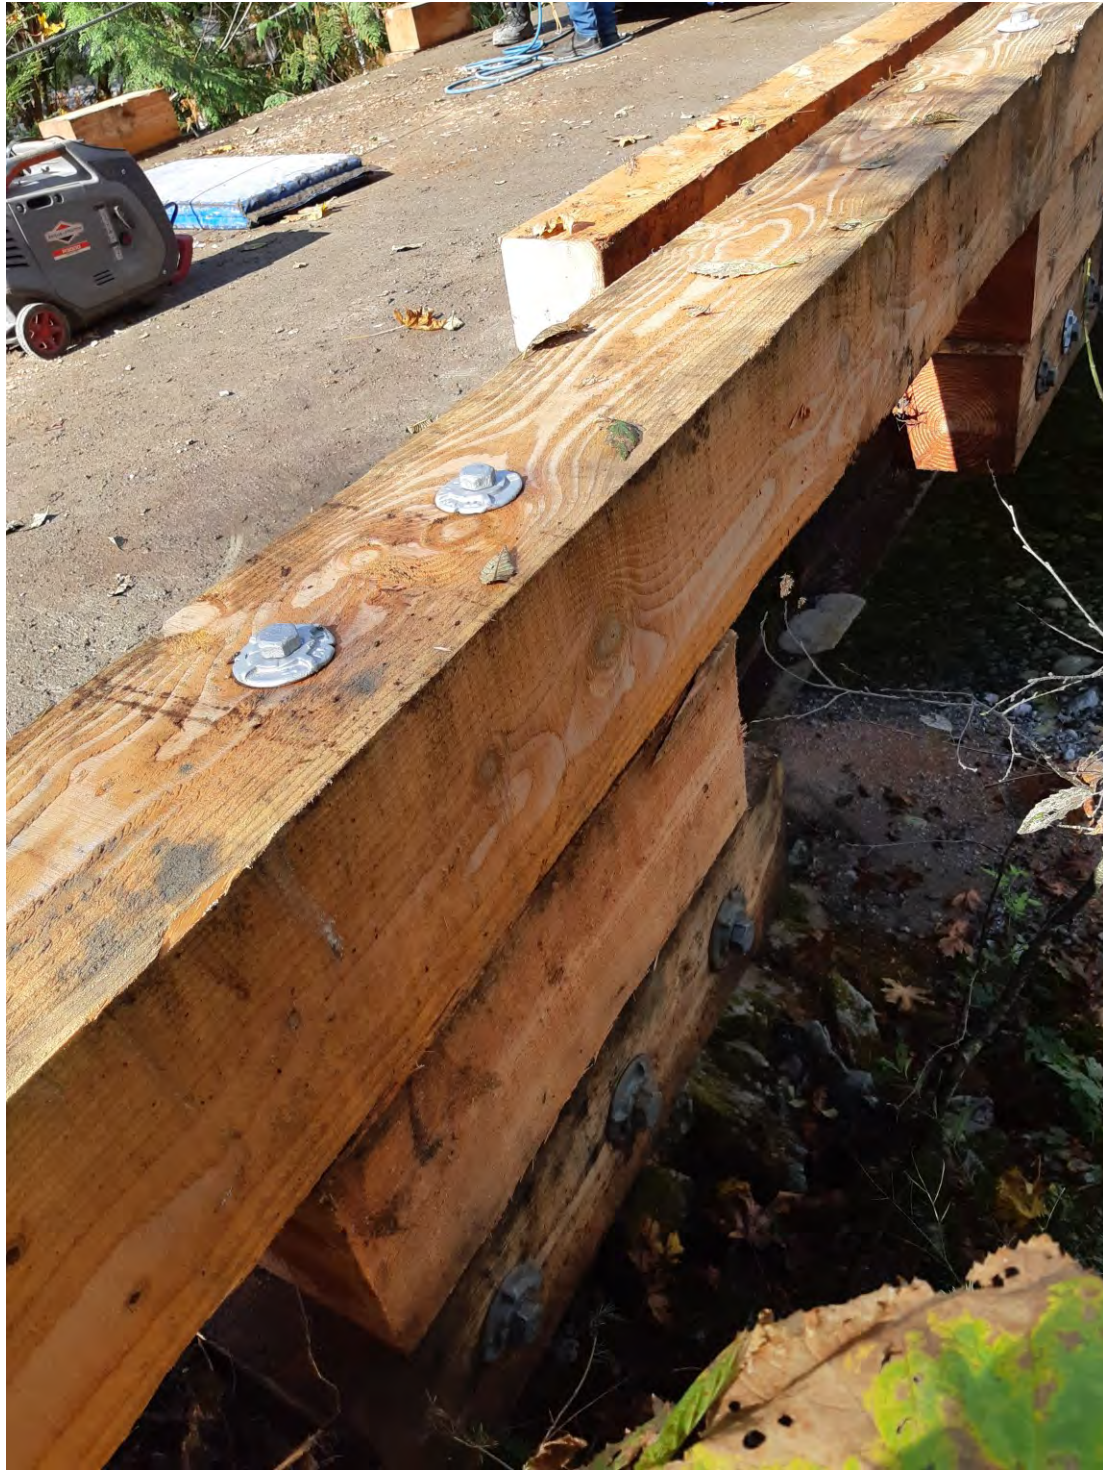
## Bridge SQ-3006

Completed – October 09, 2019
