SQ-3011

RUTHERFORD 01 6.5km

2019 Inspection

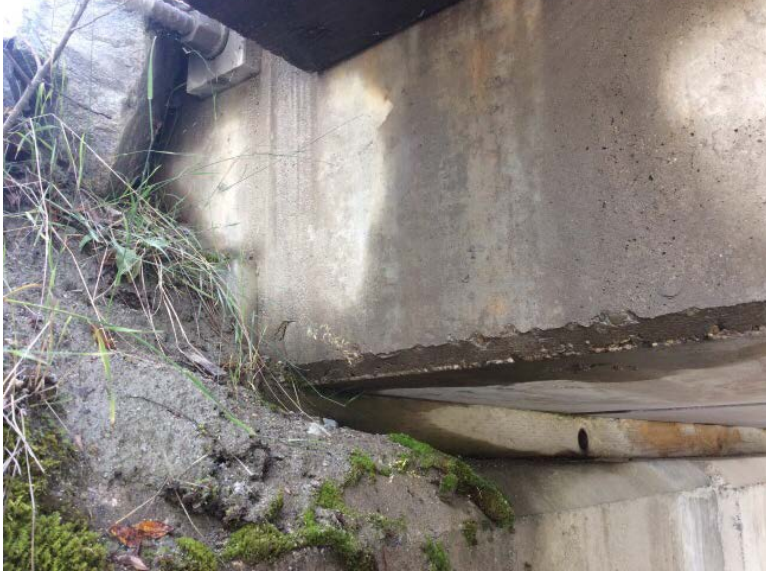
Superstructure

Appears to be grouted shear connectors - confirm with drawings

| Repair Item | Priority | Repair Description |
|---|---|---|
| 2 | Medium | Appears to be grouted shear connectors - confirm with drawings |
