SQ-3012

RUTHERFORD 01 8km

2019 Inspection

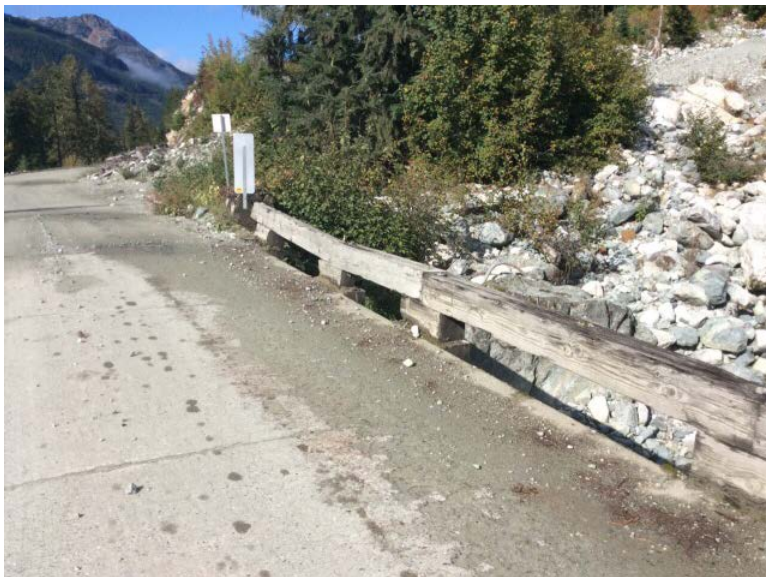
Guard Rail

Curb Rail/Blocks/Posts Poor Replace guard rails on upstream side and rotten guardrails on downstream side

Overall Deck Condition Poor Due to guard rails

| Repair Item | Priority | Repair Description |
|---|---|---|
| 1 | High | Replace guard rails on upstream side and rotten guardrails on downstream side |
