SQ-3013

RUTHERFORD 01 10km

2019 Inspection

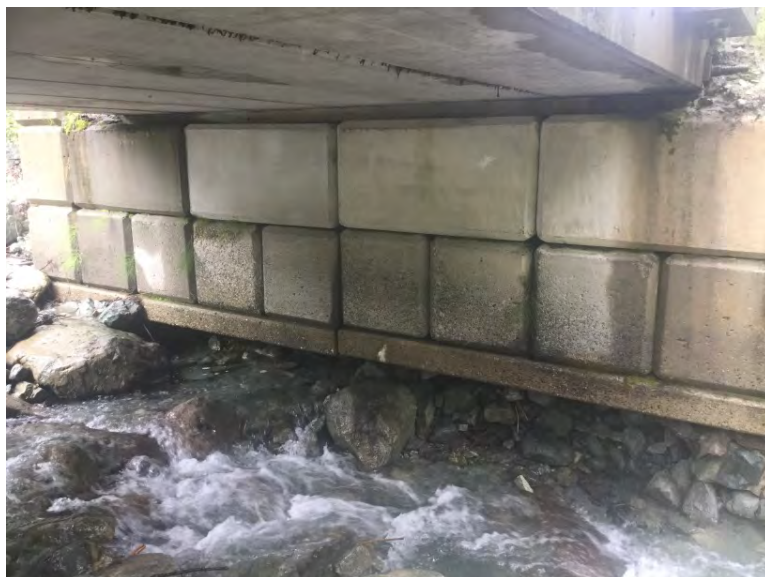
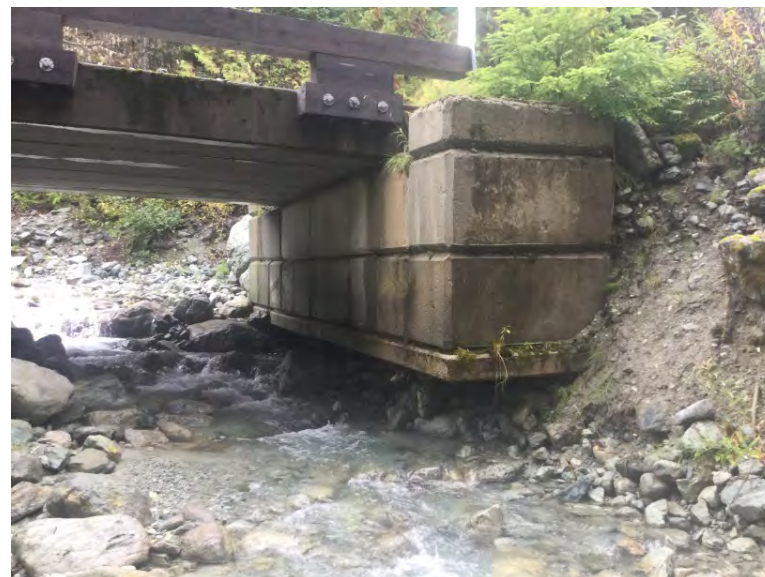
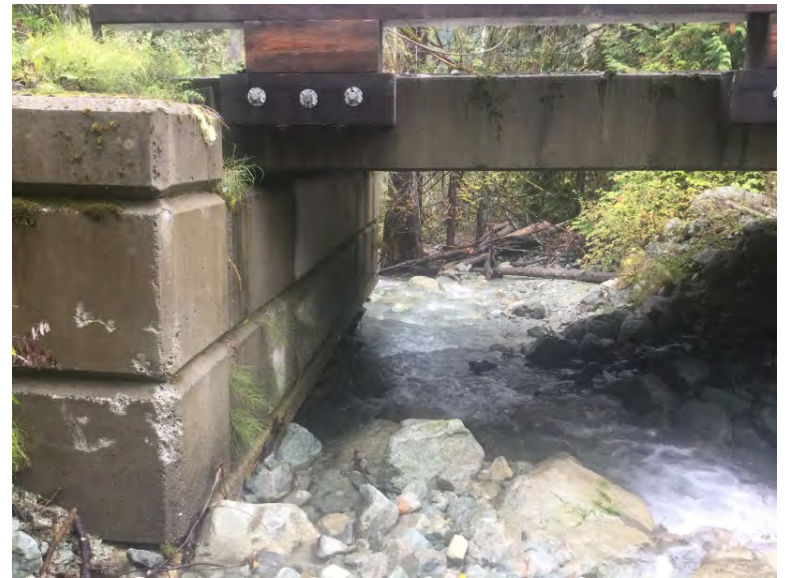
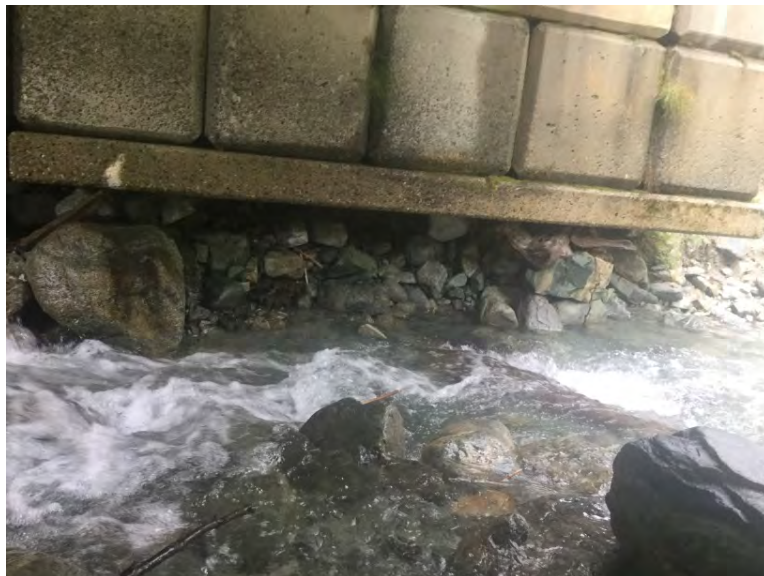
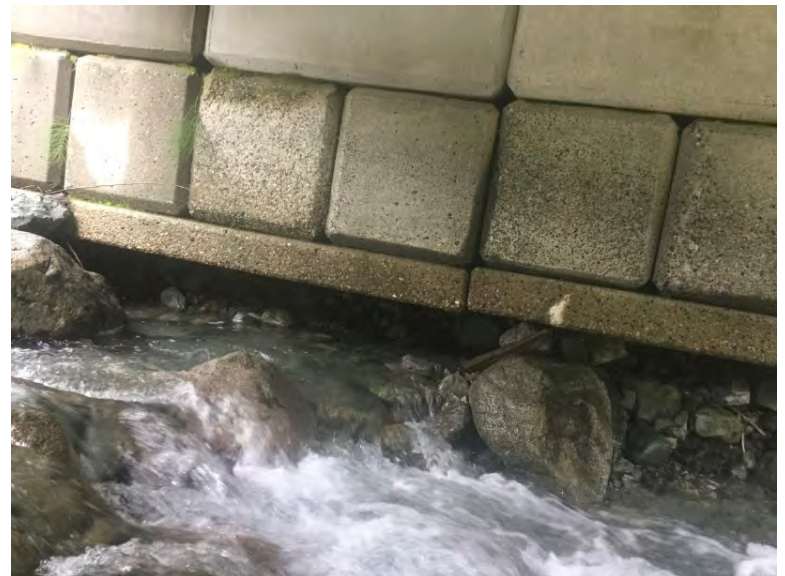
Abutment left severely undermined and scoured. Upstream side has settled approximately 1". Posted at 5 tonnes for short term. Replace as soon as possible.

Concrete Poor Severely undermined on left abutment

Fill Poor Undermined

Left Bank Abutment when facing downstream

| Item | Priority | Repair Description |
|---|---|---|
| 1 | High | Re build due to scoured abutments. |

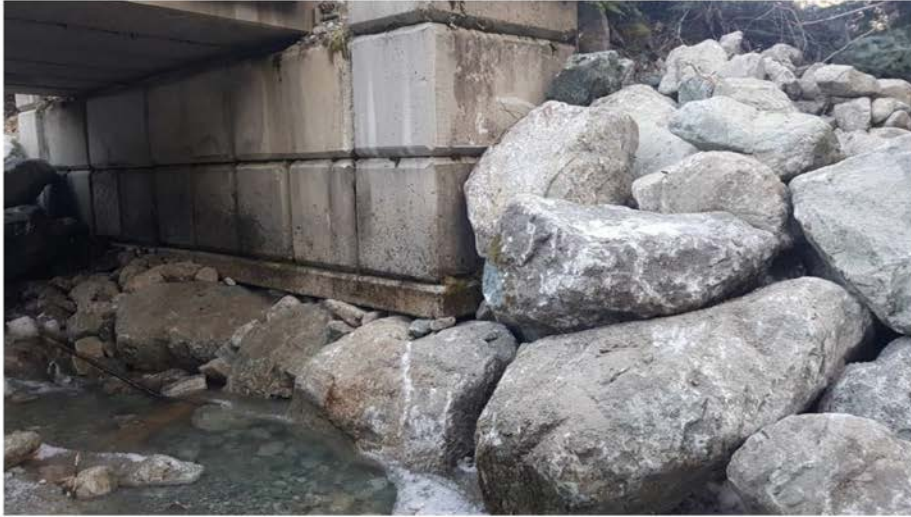
Town Abutment Upon  
Completion Of Repairs  
Looking Upstream –  
November 29<sup>th</sup>, 2019

Load Rated by: MFLNRORD, Greg Dohm, PEng., Jan. 22, 2020  
 Load Rating: 20 tonnes  
 Next Inspection: 2020  
 Comments: Undermined townside abutment has been temporary repaired. Downrate to 20 tonnes until permanent repair.
