SQ-3024

SWIFT CREEK 01 1km

2019 Inspection

| Crossing Name | Swift Creek |

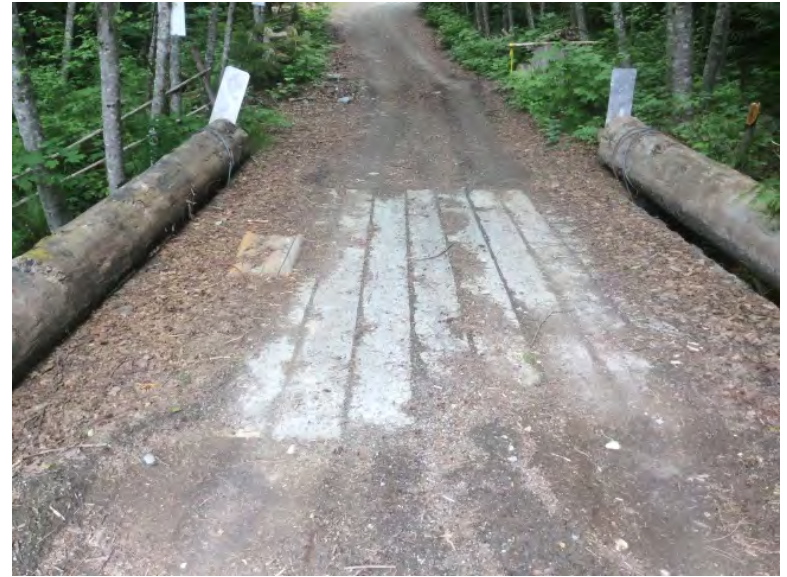
Deck

Ties Getting old (treated with rot in ends) 200x200 @ 400 Oc. and rotting but interior still generally sound with 20 mm rot but will require replacement within 2 or 3 years .  
Because stringer spacing only 16" gap between ties part deterioration of ties less of a concern.

Stringers are 14" wide x15.5" deep at 30" o.c. No rot detected in stringers.

| Item | Priority | Repair Description |
|---|---|---|
| 1 | High | Needs to replace 2 deck planks due to hole in deck from silt deposits in past per neighbour |
| 2 | Medium | Replace cross ties within 2 or 3 years. |

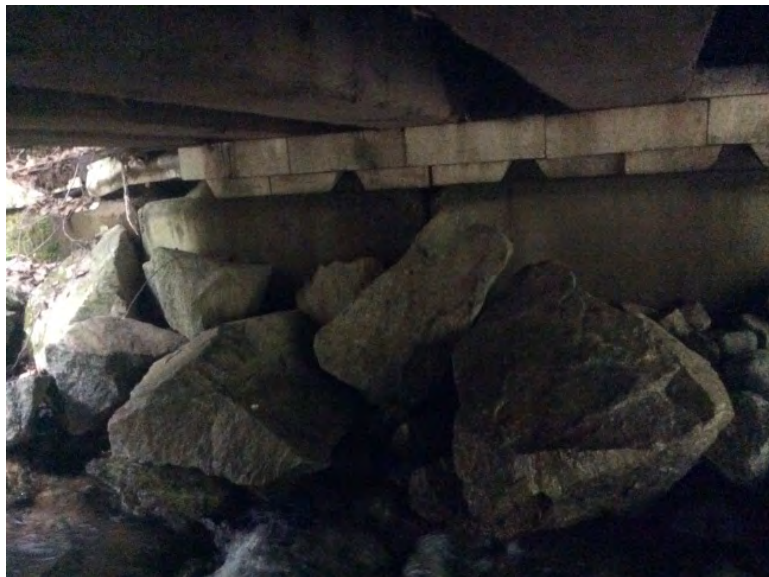
Left Bank Abutment when facing downstream

Caps or Sills Fair Abutment on left side sill covered by styrofoam by homeowner to protect homeowners waterline laid in behind bridge near sill timber.
