SQ-3028

BIRKENHEAD LOWERWEST

2019 Inspection

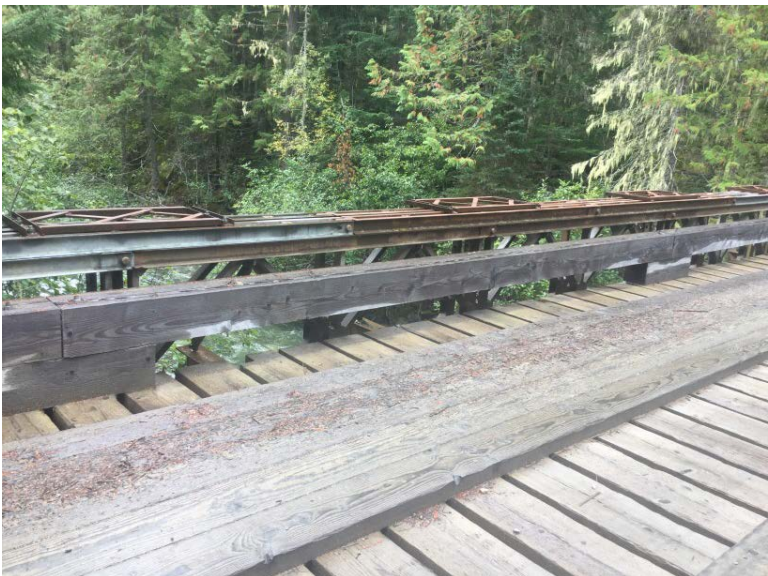
Guard Rail

Curb Rail/Blocks/Posts Fair Needs extra riser block to meet ministry standard. 1 damaged section.

| 1 | High | Add approach barriers |
