SQ-3035

LILLOOET RIVER 01 0.1km

2019 Inspection

| Crossing Name | Salmon River |

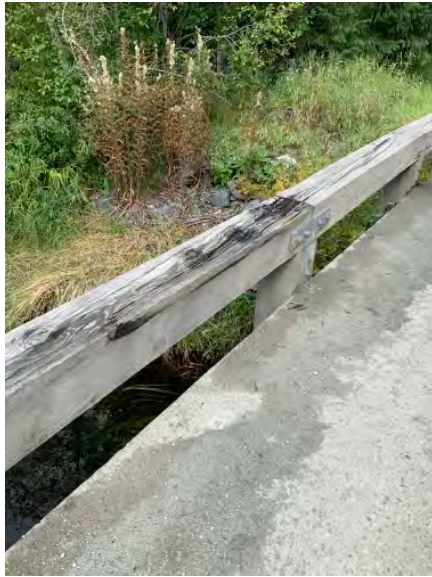
| Curb Rail/Blocks/Posts | Fair | Rails getting old. Some rot starting to show. Should replace in next 2 years. |

Guard Rail

Load Rated by: MFLNRORD, Greg Dohm, PEng., Jan. 24, 2020  
Load Rating: L60 or 54 tonnes  
Next Inspection: 2021  
Comments: Replace all curb rail components in next 2 years.

| Repair Item | Priority | Repair Description |
|---|---|---|
| 1 | Medium | Replace all guardrail components in next 2 years. |

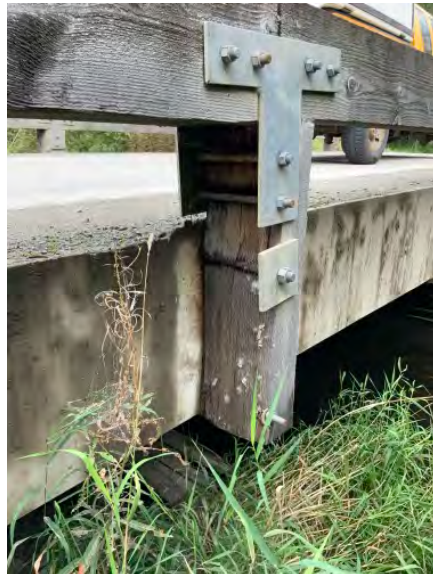
Guard Rail post damage downstream right side
