SQ-3044

LILLOOET RIVER 01 10.4km

2019 Inspection

| Crossing Name | Sampson Creek |

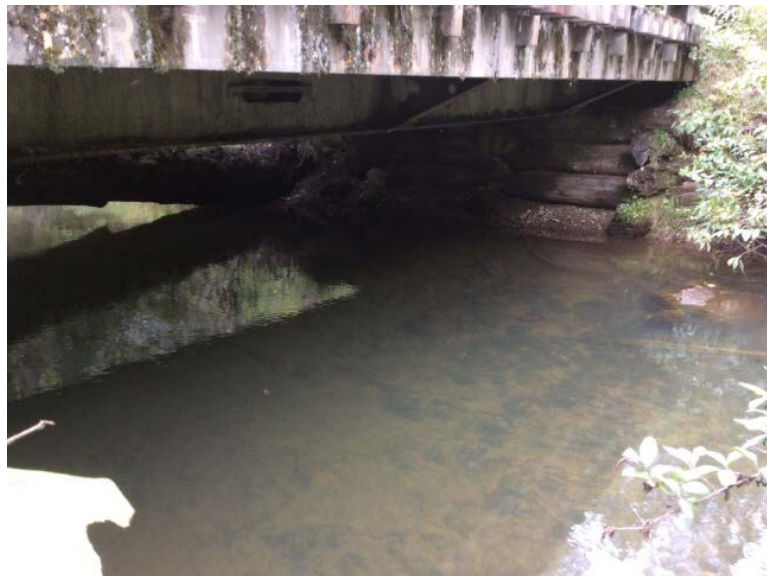
Left Bank Abutment when facing downstream

Log/Timber Cribs Fair Fair to poor condition. Rail car bears behind crib 2.5m

Tie Backs Poor Fair to poor condition. Rail car bears behind crib
