SQ-3051

LEVETTE LAKE 01 2.7km

2019 Inspection

| Crossing Name | Evans Creek |

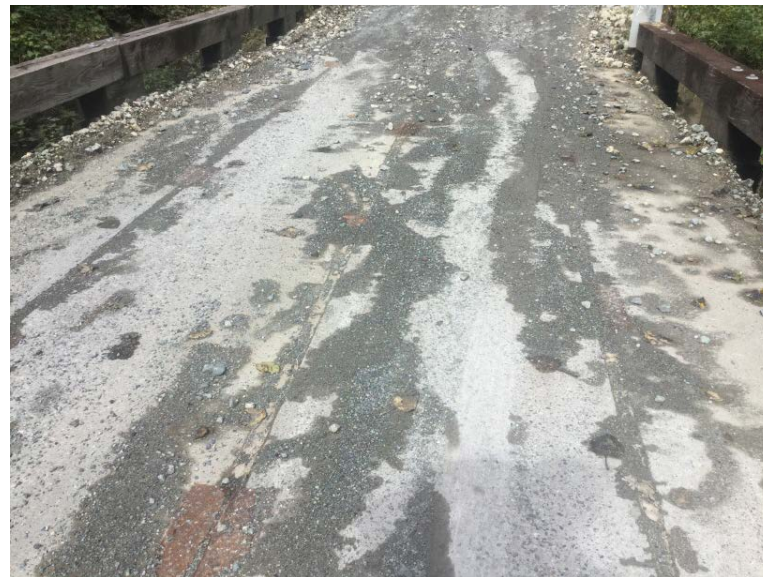
Overall Deck Condition      Good

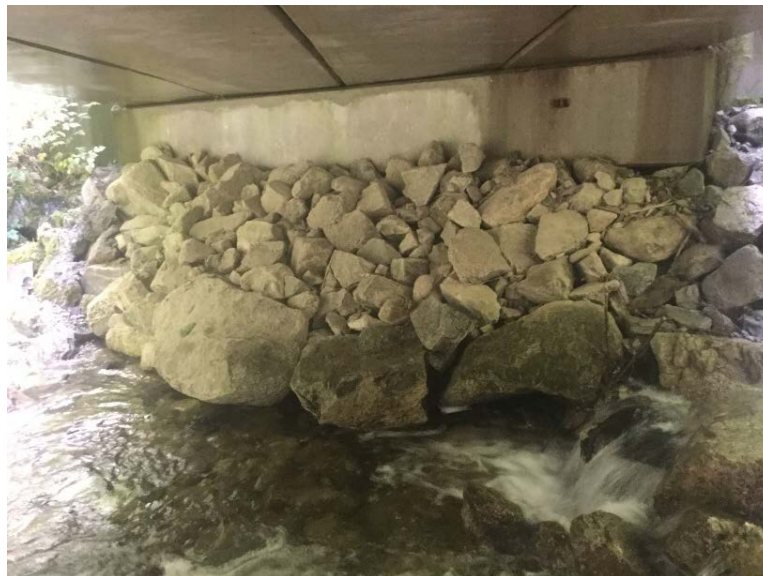
Right Bank Abutment when facing downstream

Riprap Fair Erosion right side. Monitor.

1 Onitor scour right abutment
