SQ-3052

BROHM RIDGE 0.1km

2019 Inspection

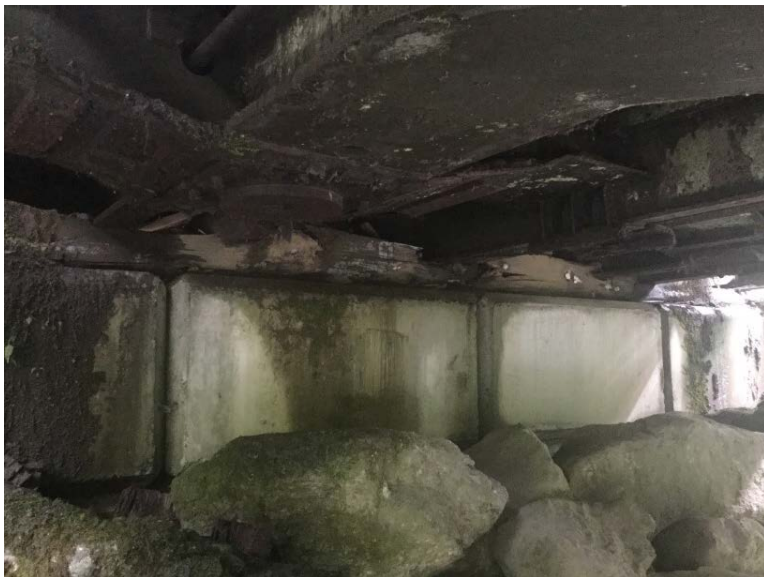
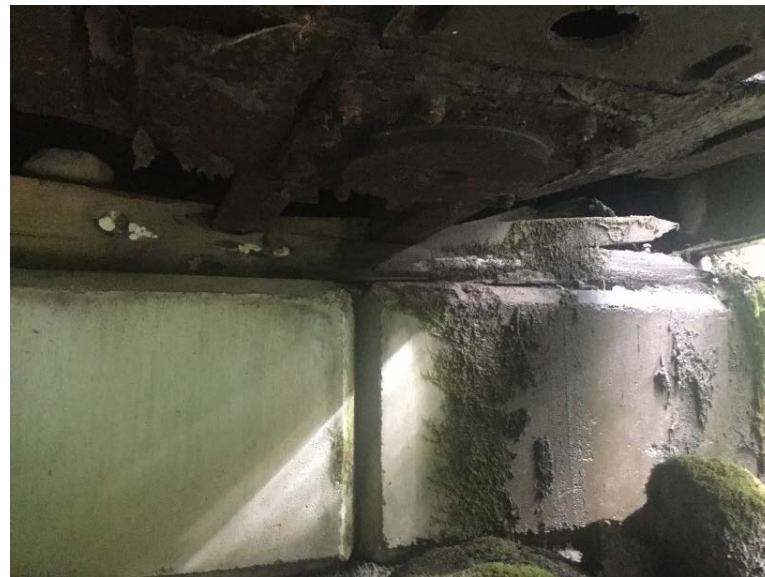
Left bank sill

Caps or Sills Poor Timber 10"x10" severely crushed on left, starting to crush on right

Bearings Poor Crushed timbers

| 1 | Medium | Replace timber sills |

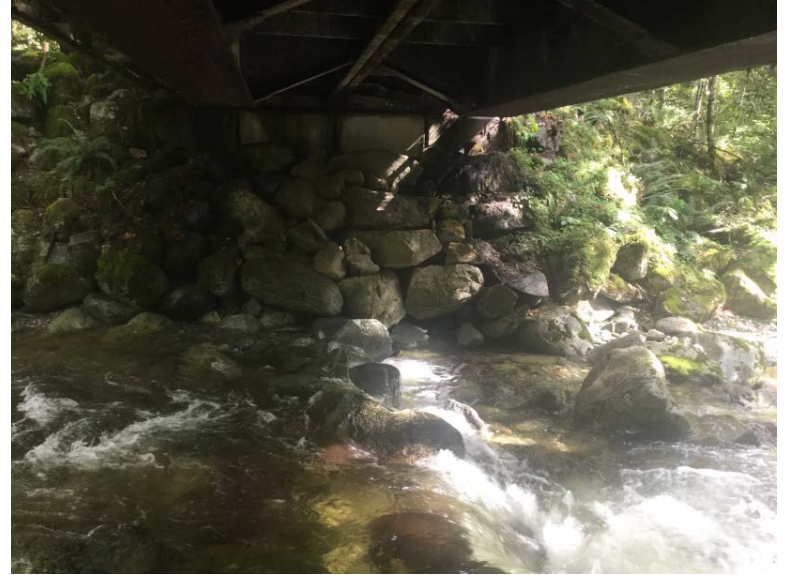
Left Bank Abutment when facing downstream

Riprap Fair Minor scour left side. Monitor.

| Item | Monitor Description | Frequency |
|---|---|---|
| 1 | Monitor riprap left side | Routine Inspection |
