SQ-3057

IN-SHUCK-CH FSR 7.7km

2019 Inspection

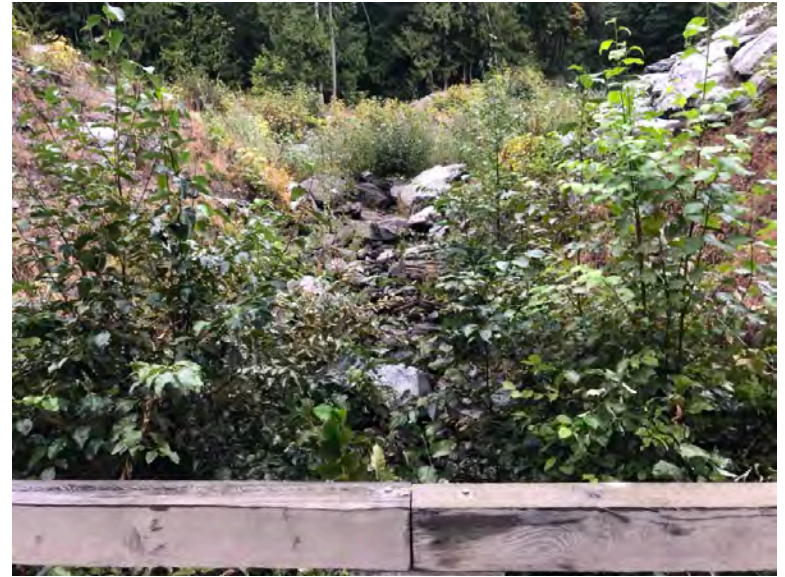
Upstream from Crossing

Comments Debris flow channel. Water clearance is for normal water only. E

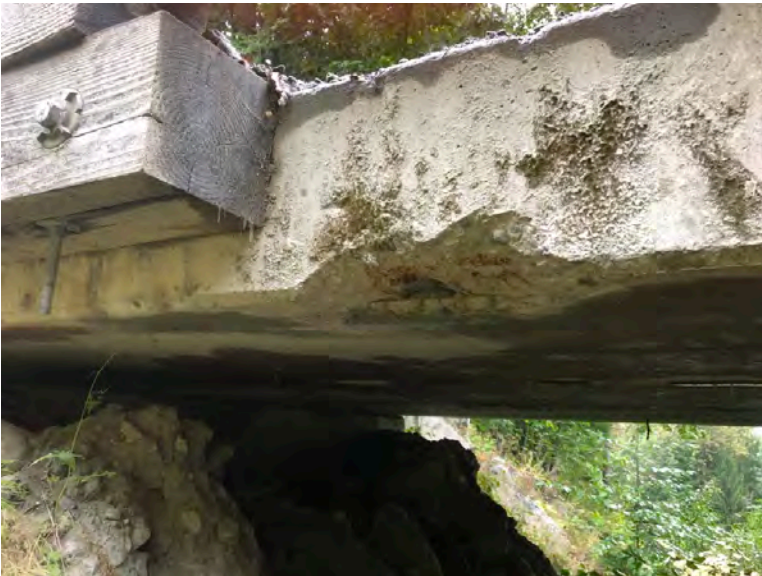
Minor edge in damage to slab upstream.

Minor slab damage upstream
