SQ-3058

IN-SHUCK-CH FSR 10km

2019 Inspection

| Crossing Name | Twin One Creek |

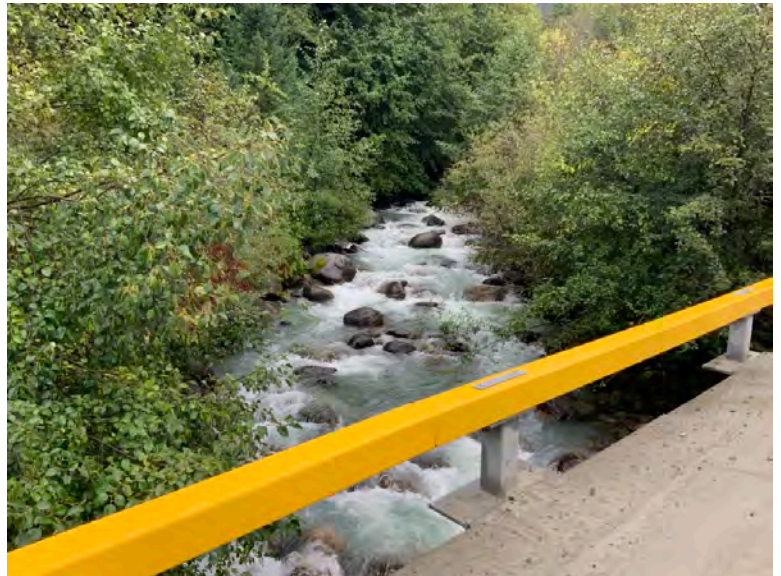
Upstream from Crossing

Comments Evidence of debris flows in this channel.
