SQ-3067

IN-SHUCK-CH FSR 56km

2019 Inspection

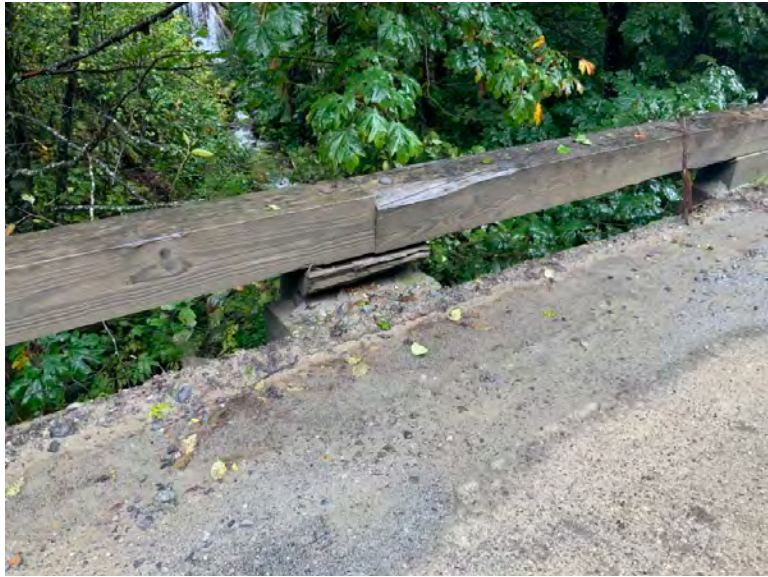
Guard Rail

Curb Rail/Blocks/Posts      Poor      Replace broken risers ASAP and look to replace both guardrails in next 12 months due to rot starting.

| Item | Priority | Repair Description |
|---|---|---|
| 1 | High | Replace broken risers ASAP and look to replace both guardrails in next 12 months due to rot starting. |
