SQ-3069

IN-SHUCK-CH FSR 65km

2019 Inspection

| Crossing Name | 12 Mile Creek |

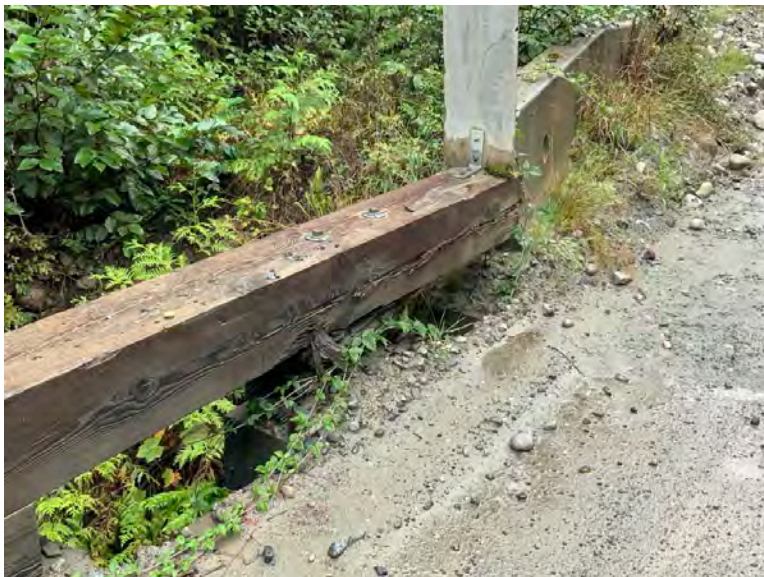
Guard Rail

Curb Rail/Blocks/Posts      Fair      Will need to replace in next 2 years

Load Rated by: MFLNRORD, Greg Dohm, PEng., Jan. 24, 2020  
Load Rating: BCL625 or 63 tonnes  
Next Inspection: 2021  
Comments: Replace curb rails within 2 years.
