SQ-3074

CHANCE CREEK 0.05km

2019 Inspection

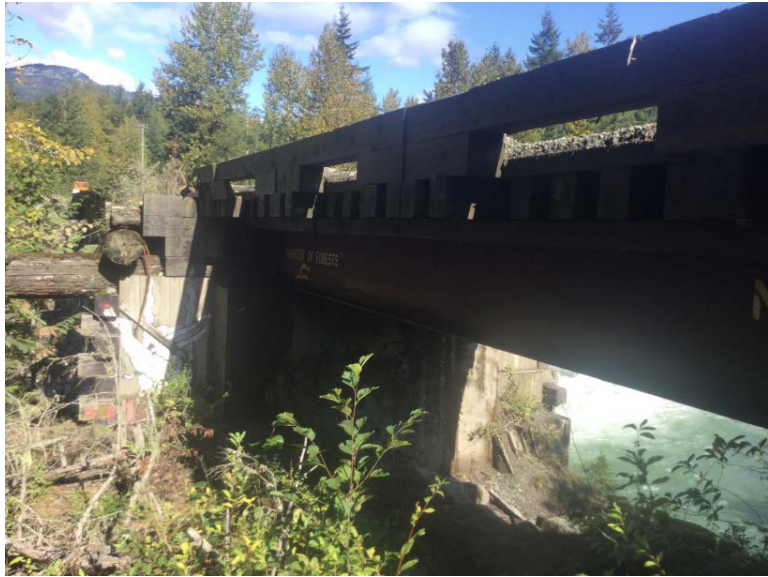
Log/Timber Cribs Fair Old creosote ties. Inaccessible. Appear ok. May require close proximity inspection.

Left Bank Abutment when facing downstream

| Item | Monitor Description | Frequency |
|---|---|---|
| 1 | Monitor crib left abutment side. | Routine Inspection |

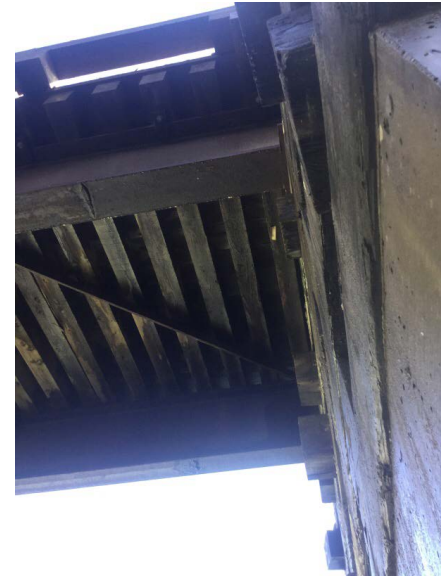
Left pier, stream side

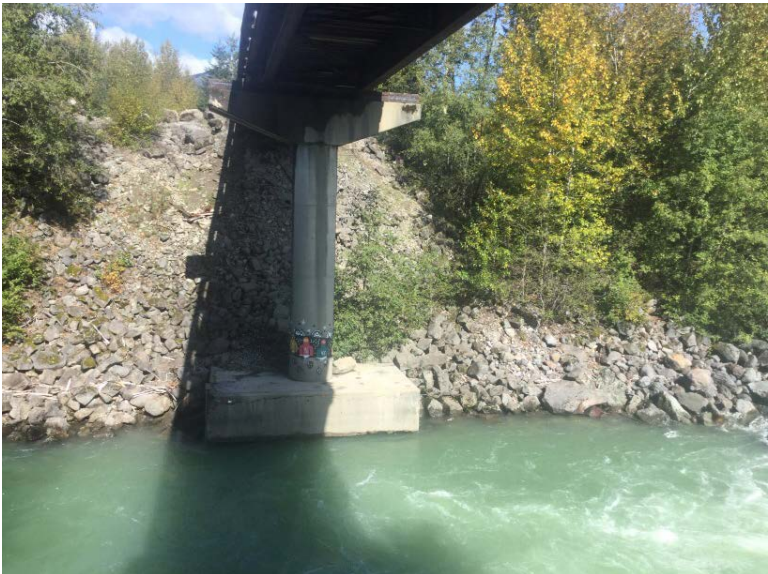
Pier Fair Footing inaccessible due to high water.

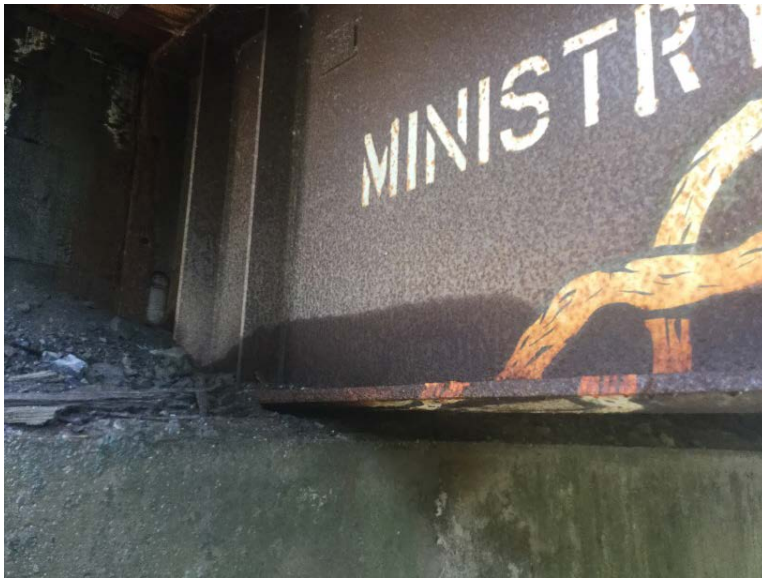
Town side jump span - dirt on girders

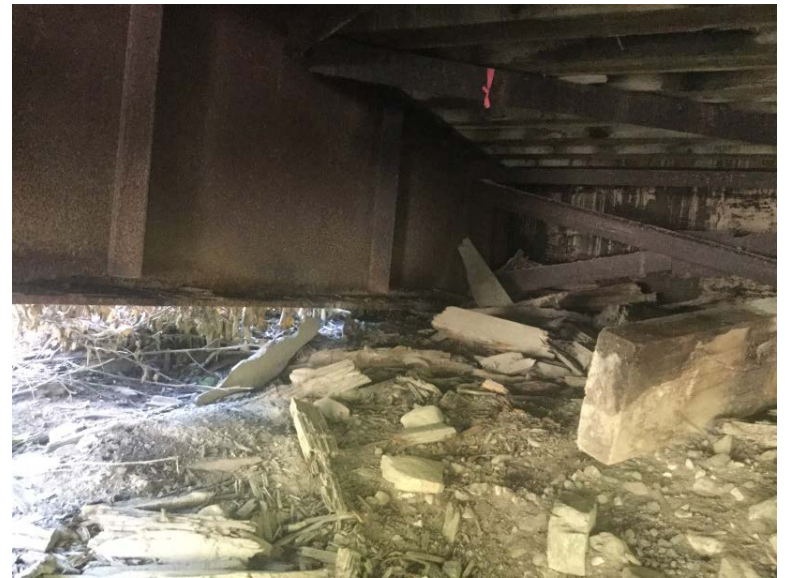
Jump span has corrosion and delamination on bottom flange.

Town jump span - corrosion on girders

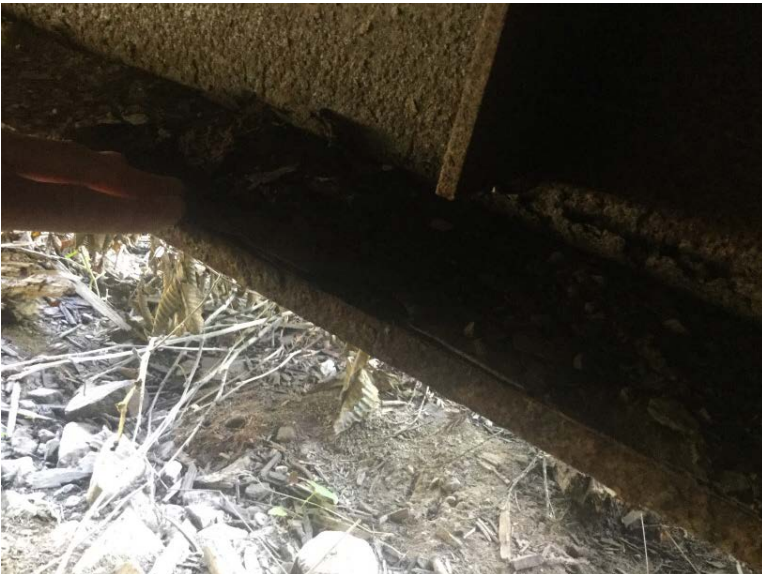
Town jump span - corrosion on girders

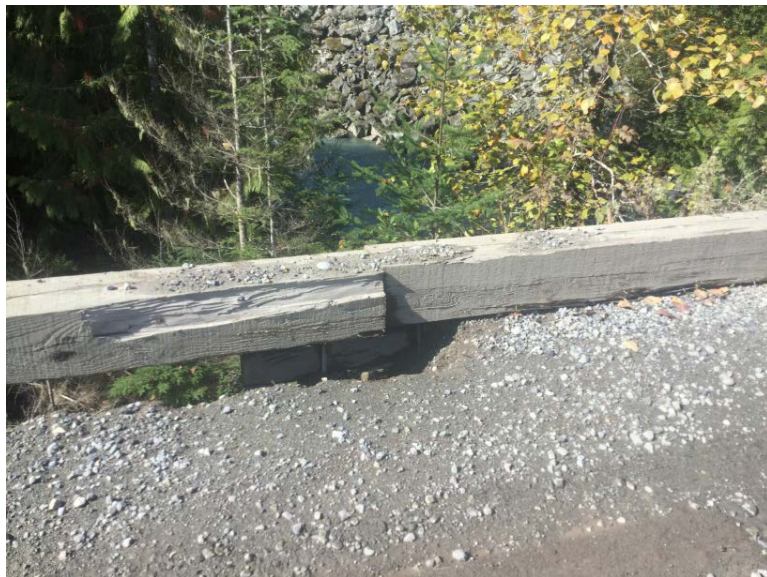
Guard Rail

Fender Condition Poor Small / missing. Replace with no post barriers.

| Repair Item | Priority | Repair Description |
|---|---|---|
| 1 | High | Add approach barriers |

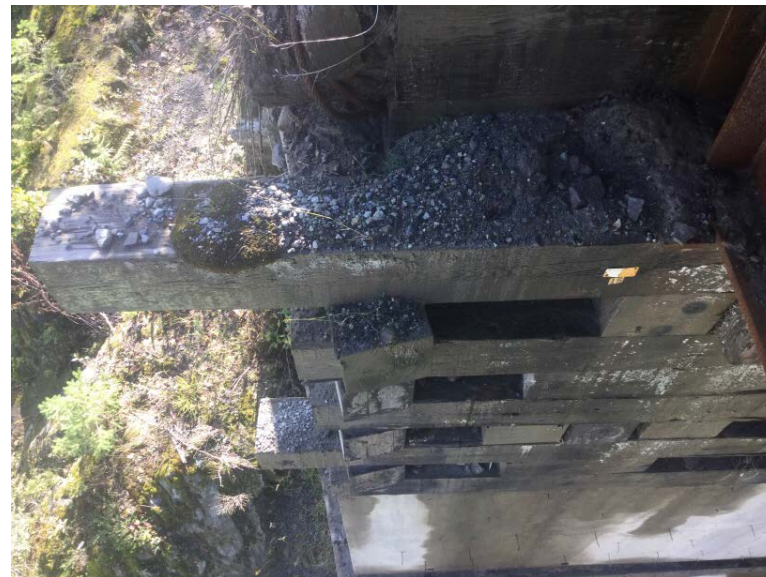
Caps or Sills Fair Inaccessible, appear ok.

Main span, left abutment sill

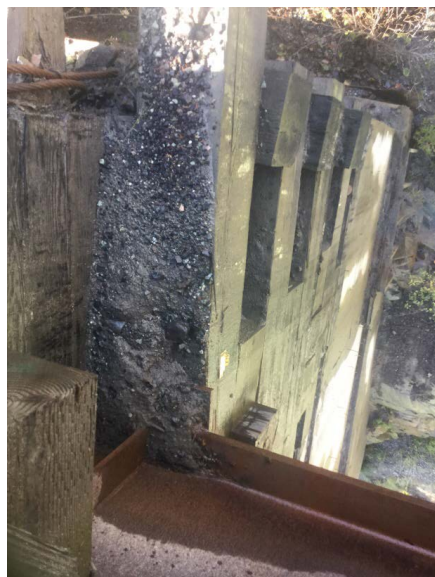
Main span, left abutment sill - downstream side

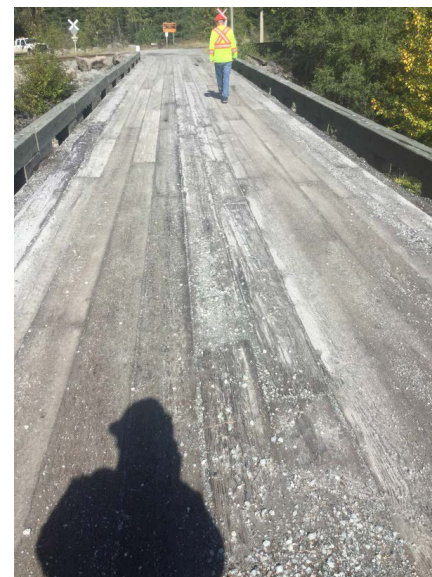
Deck

Running Planks Fair Some broken running planks

| Repair Item | Priority | Repair Description |
|---|---|---|
| 2 | High | Replace broken running planks |
