SQ-3078

RING CREEK NORTH 5.2km

2019 Inspection

| Crossing Name | Brandvold Creek |

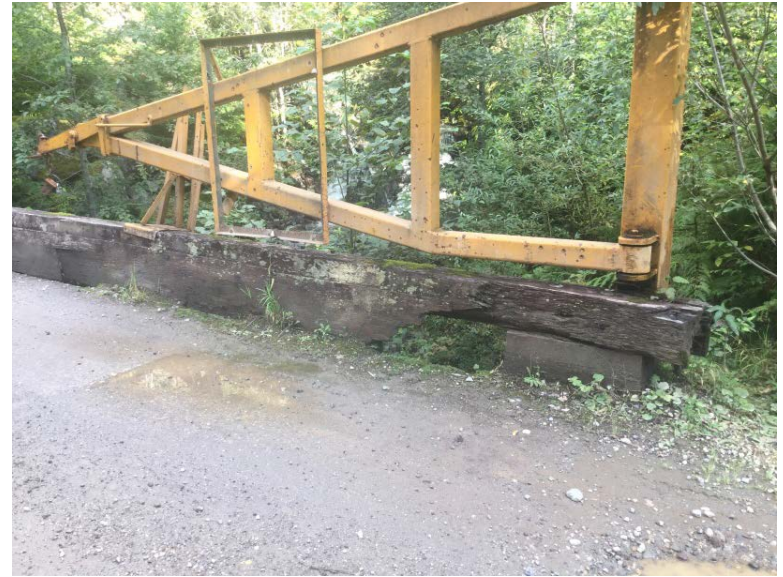
Guard Rail

Curb Rail/Blocks/Posts Poor Rotten; Replace

| 1 | High | Replace guardrails |

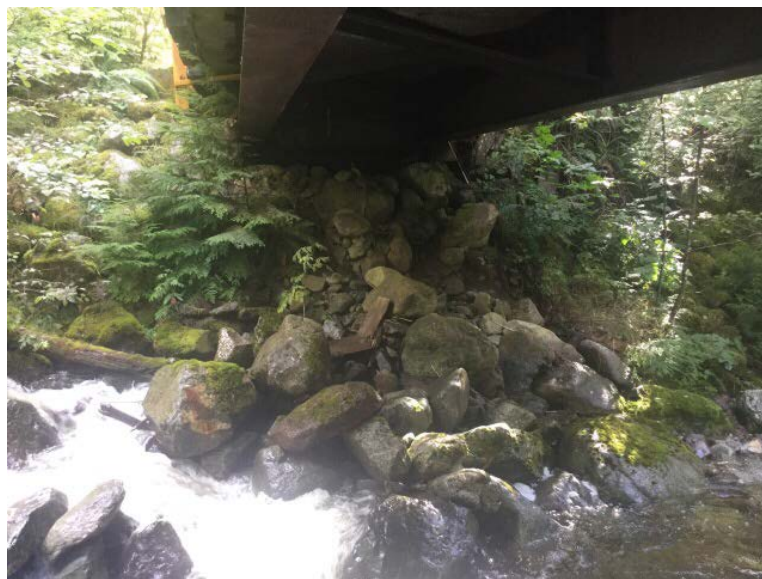
Left Bank Abutment when facing downstream

Riprap Fair Scour left side
