SQ-3083

LILLOOET SOUTH 01 3.5km

2019 Inspection

| Structure Class | Temporary Bridge |

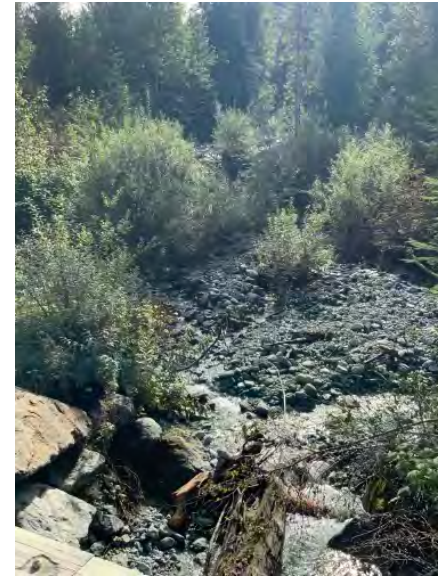
Upstream from Crossing

Comments Looks like old debris flow stopped just upstream. This bridge could easily washout in a future debris flow as upstream fan is quite large.

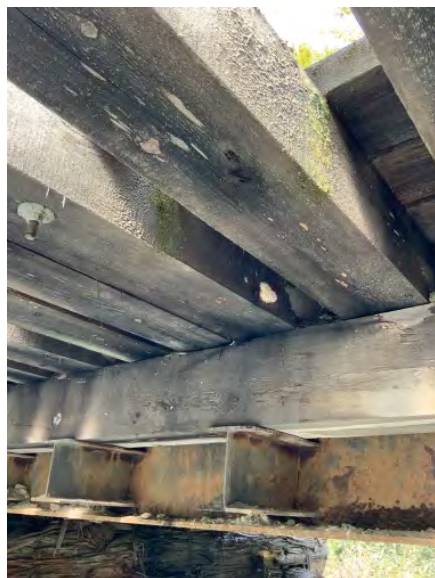
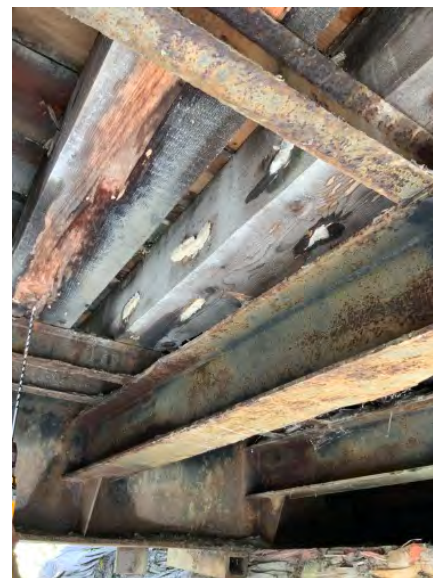
Ties      Fair      400 c/c

Ties starting to get fungus

| Repair Item | Priority | Repair Description |
|---|---|---|
| 1 | Medium | Replace ties, deck and guardrails. |

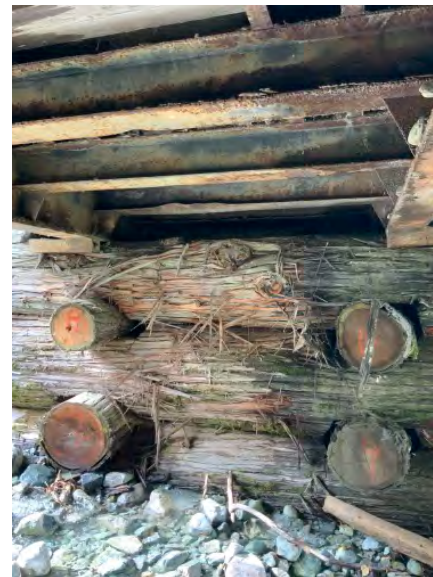
Left Bank Abutment when facing downstream

Log/Timber Cribs Good 3 high cw each side

Tie Backs Fair Replace ties in next 2 years. Rot starting to show, but drilled ties were still sound inside n
