SQ-3091

GREEN RIVER 01 5.5km

2019 Inspection

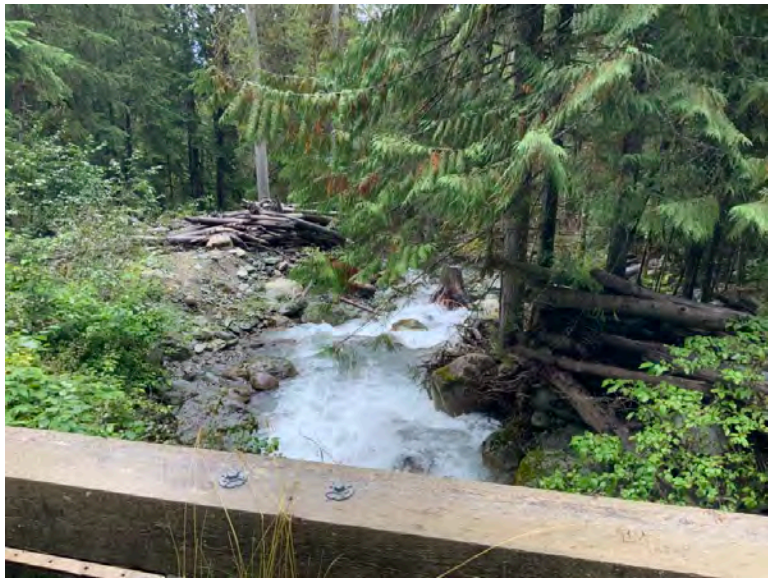
Downstream from Crossing

Comments Debris flow did pass underneath at some point indicative of the log jam downstream.

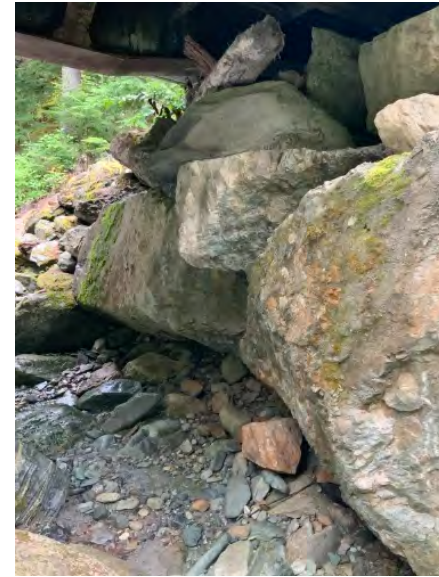
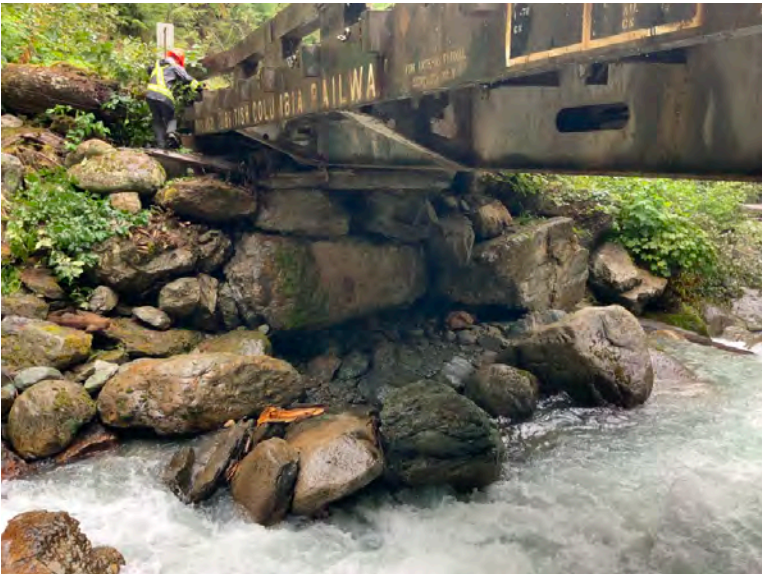
Left Bank Abutment when facing downstream

Riprap is over steep and eroded on left side. If riprap was to move it will likely compromise the lock locks and superstructure.

| Item | Priority | Repair Description |
|---|---|---|
| 1 | | Should either fix abutment or replace structure at next industrial use. |

| 1 | Monitor riprap as it could move and compromise structure either annually or after a large rain storm event. | Annually |
