SQ-3103

FURRY CREEK 02 0.6km

2019 Inspection

| Crossing Name | Phyllis #3 |

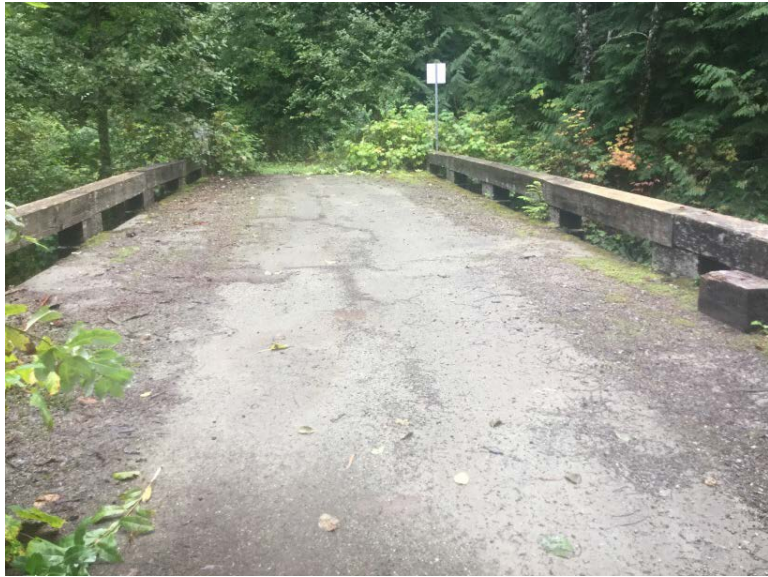
Approach from Left Bank when facing downstream

Fender Condition Poor Missing

Road Surface Poor Overgrown

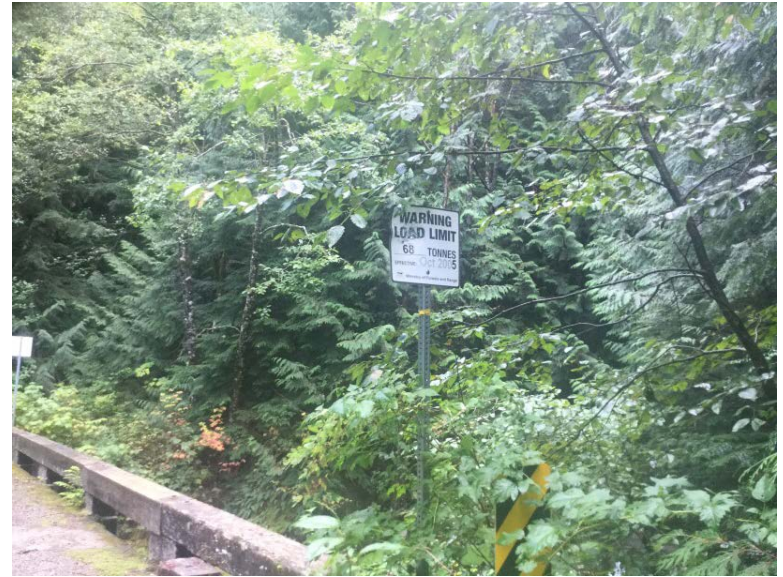
Load Rating Sign

Posted Load Rating 68
