SQ-3104

FURRY CREEK 03 0.1km

2019 Inspection

| Crossing Name | Phyllis Creek |

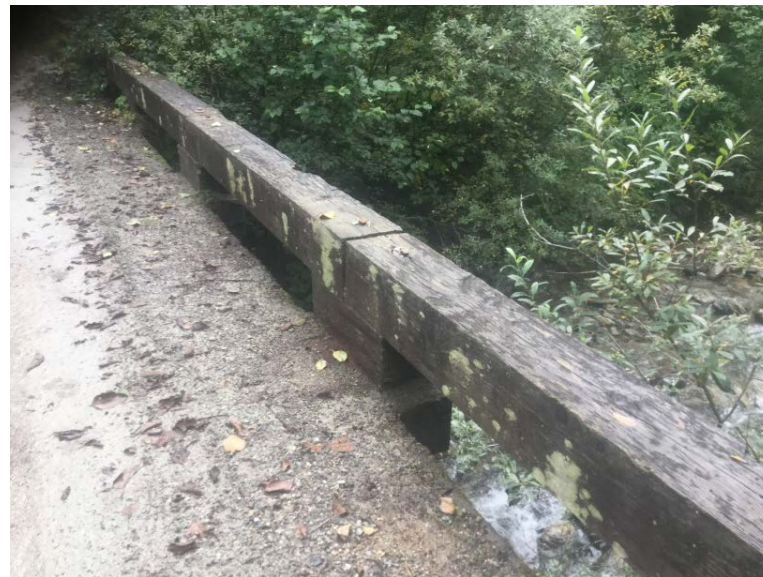
Guard Rail

Curb Rail/Blocks/Posts Poor Rotten, replace

Load Rated by: MFLNRORD, Greg Dohm, PEng., January 29, 2020  
Load Rating: L75 or 68 tonnes  
Next Inspection: 2022  
Comments: replace broken curb blocks prior to industrial use

| 1 | High | Replace guardrails |
