SQ-3106

BLACKWATER MAINLINE 0.1km

2019 Inspection

| Crossing Name | Blackwater Creek | | |

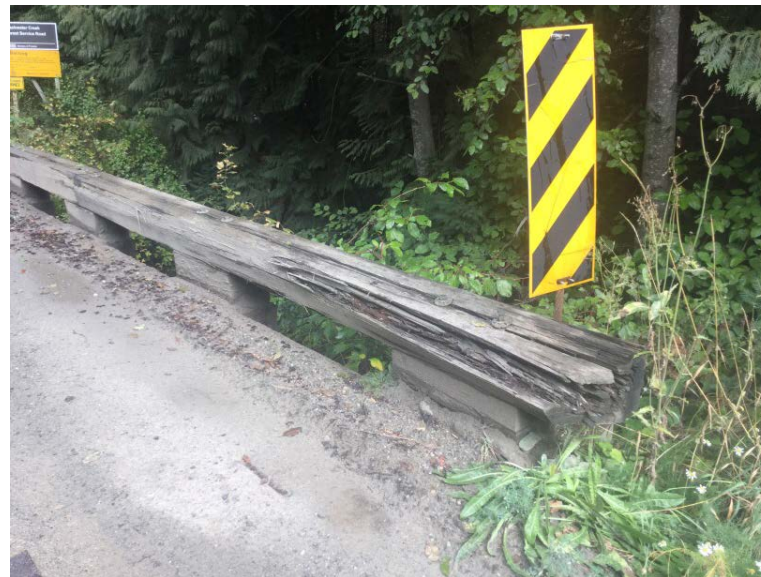
Guard Rail

Curb Rail/Blocks/Posts Poor Rotten

Comments: replace curb rails for continued industrial use. Repair concrete deck damage. Contact Ministry Engineering for repair procedure.

| 2 | High | Replace guardrails |

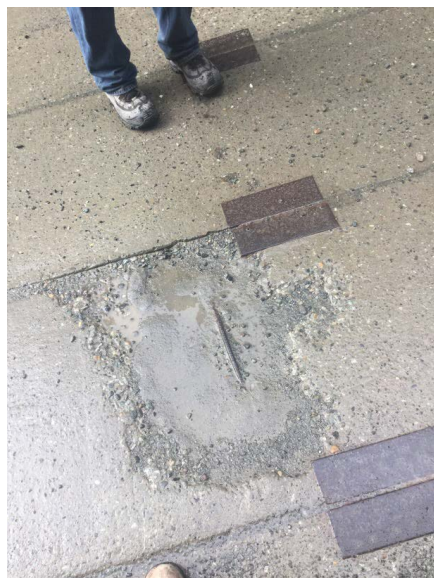
Concrete damaged on deck requires repair 2 sections approx 1m x 1m, and 0.2m x 0.2m, by 50mm deep both sections. Appears do have been previously repaired. Rebar showing on both sections.

Concrete Deck Fair Concrete damaged in two locations. Repair.

| 1 | High | Repair concrete deck |
