SQ-3108

BLACKWATER MAINLINE 12km

2019 Inspection

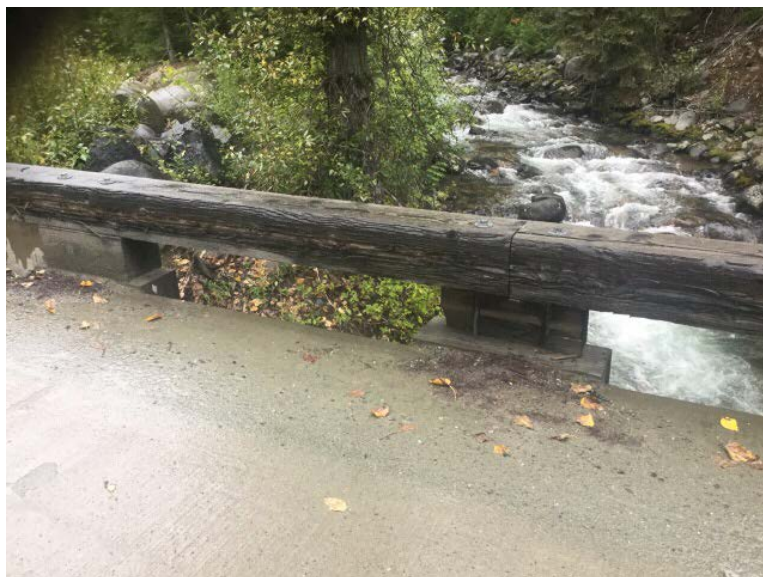
Guard Rail

Guardrail block requires repair. All rail components will require replacement within estimated 3 years.

Curb Rail/Blocks/Posts      Poor      Loose, damaged upstream side

Load Rated by: MFLNRORD, Greg Dohm, PEng., January 29, 2020  
Load Rating: BCL625 or 63 tonnes  
Next Inspection: 2022  
Comments: replace broken curb blocks prior to industrial use and curb rails within 3 years

| 1 | Medium | Repair guardrails |
