SQ-3111

LILLOOET WEST 01 0.5km

2019 Inspection

| Crossing Name | Tipella Creek |

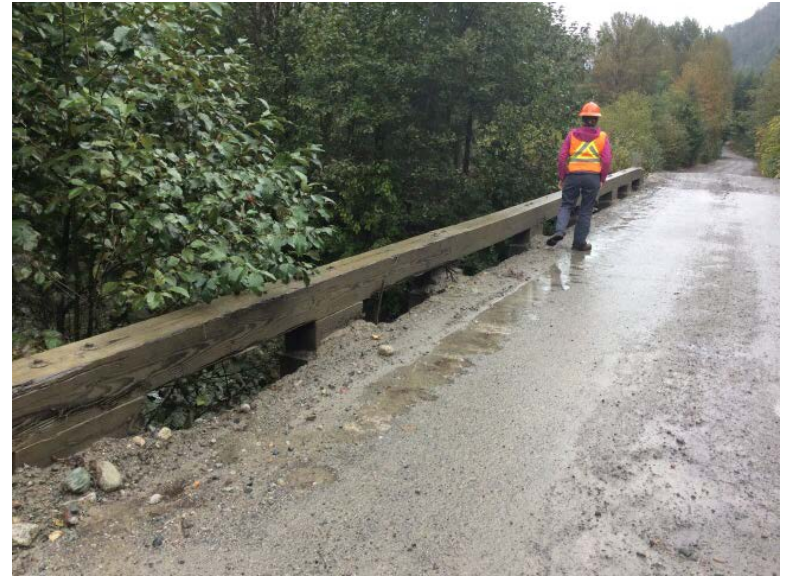
Guard Rail

Curb Rail/Blocks/Posts      Poor      Some broken curb block risers require repair

| Repair Item | Priority | Repair Description |
|---|---|---|
| 1 | High | Some broken curb block risers require repair |

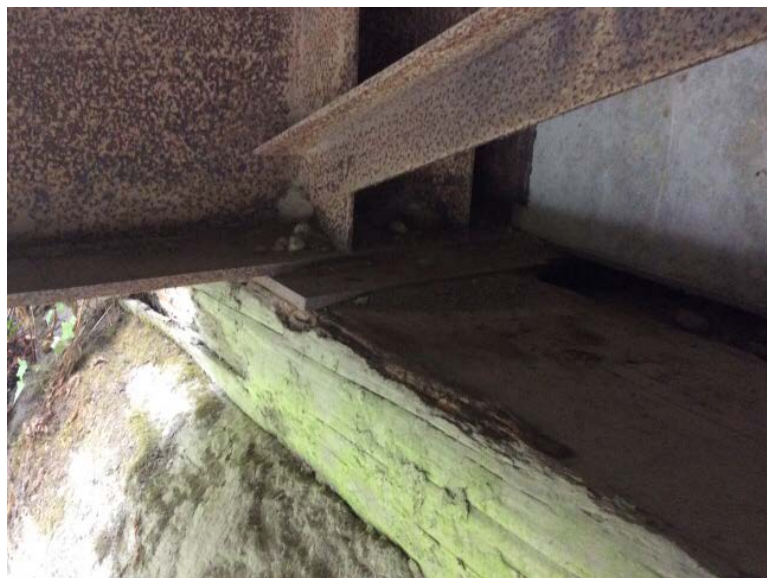
Bearing

Bearings Fair
