SQ-3113

LILLOOET WEST 01 72.9km

2019 Inspection

| Crossing Name | Fire Creek |

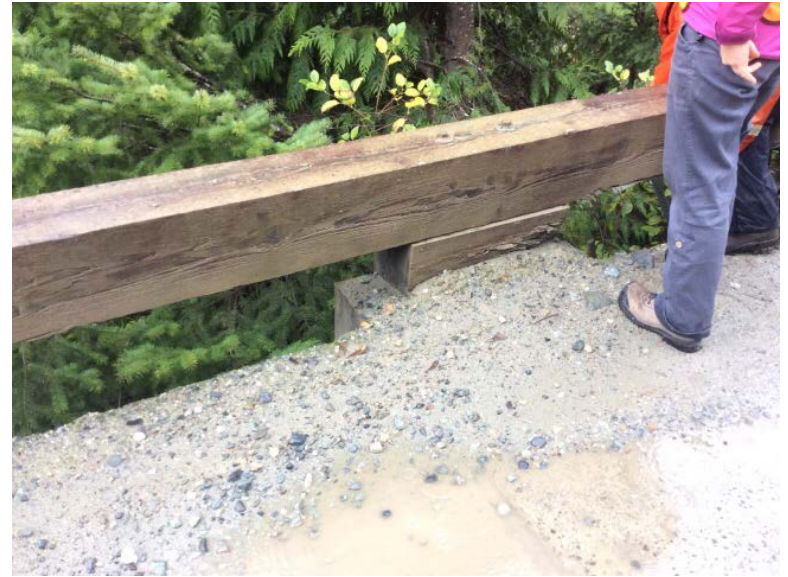
Guard Rail

Curb Rail/Blocks/Posts Poor Some curb blocks and risers are rotten and require replacement before industrial use

| Item | Priority | Repair Description |
|---|---|---|
| 1 | High | Some curb blocks and risers are rotten and require replacement before industrial use |
