SQ-3114

LILLOOET WEST 01 66.7km

2019 Inspection

| Crossing Name | Spring Creek (11 mile) |

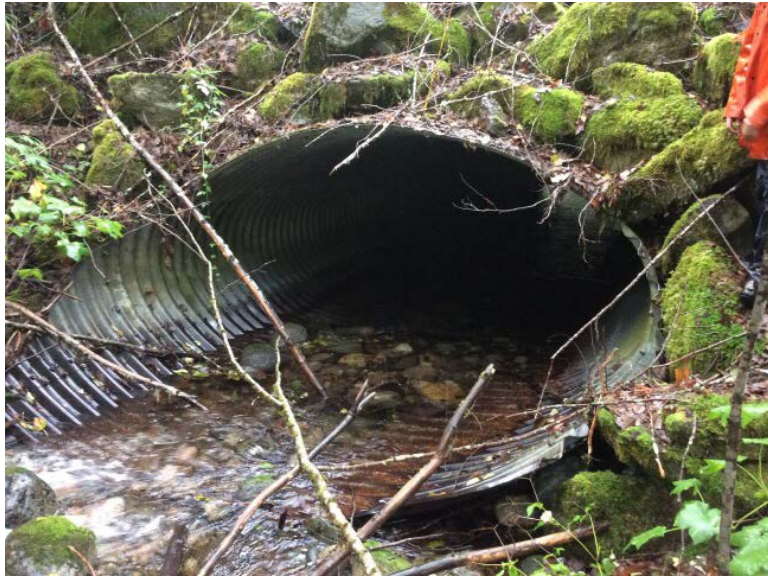
Inlet Fair

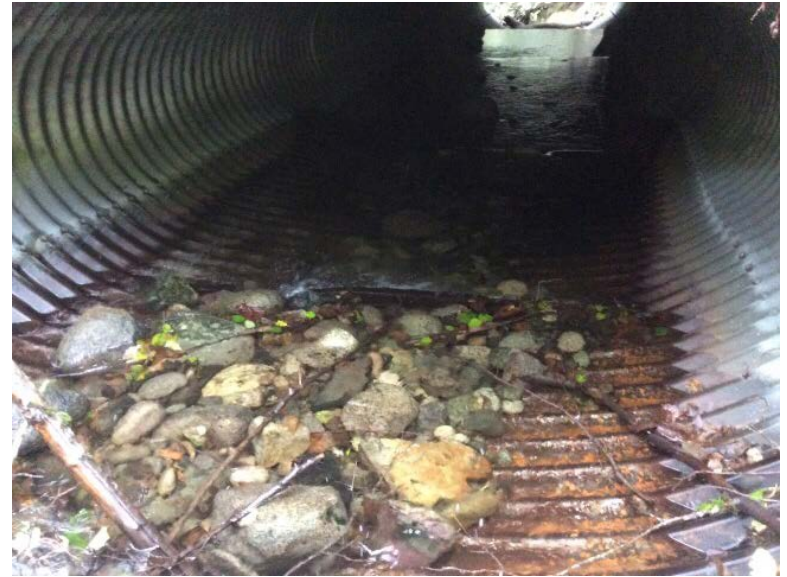
Bottom

Floor Fair

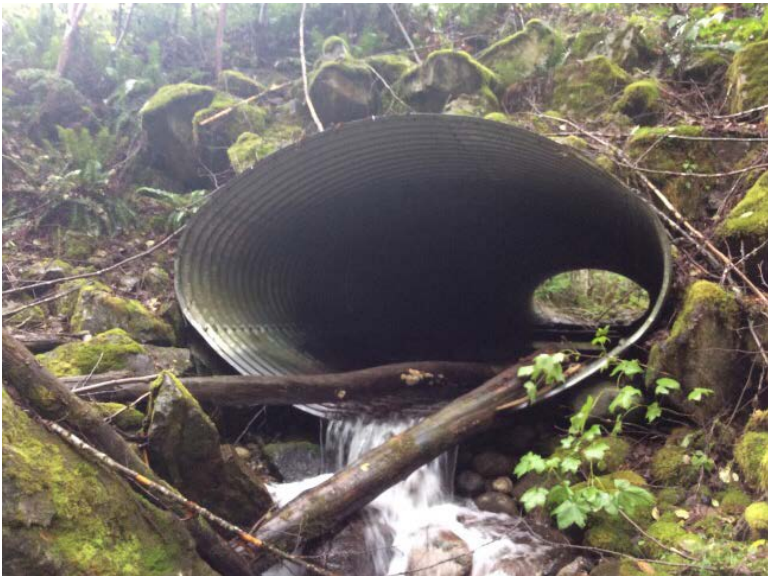
Outlet Fair
