SQ-3125

CHANCE CREEK 0.4km

2019 Inspection

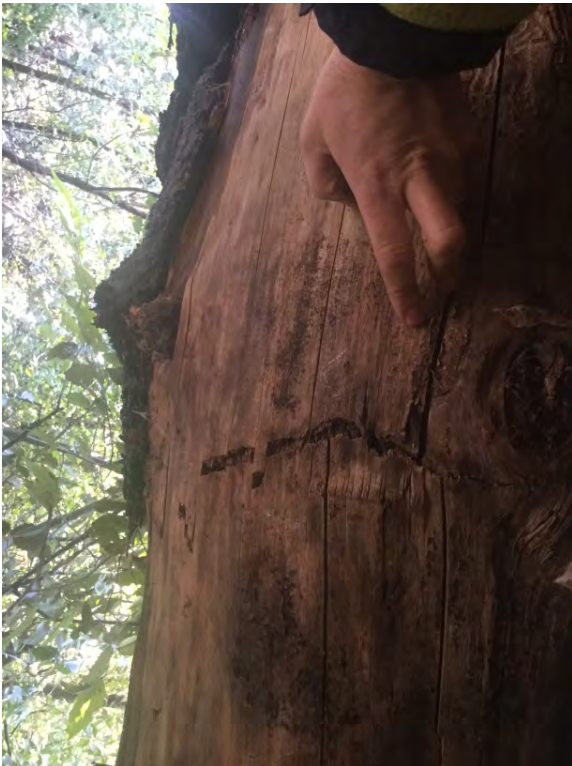
| Stringer<br>Number | Species | Peeled | Diameter<br>(mm) | Rot Depth<br>(mm) | Condition | Comment |
|---|---|---|---|---|---|---|
| 12 | Fd | | | 100 | | Cracked midspan, conk |

Stringer 12 - conk

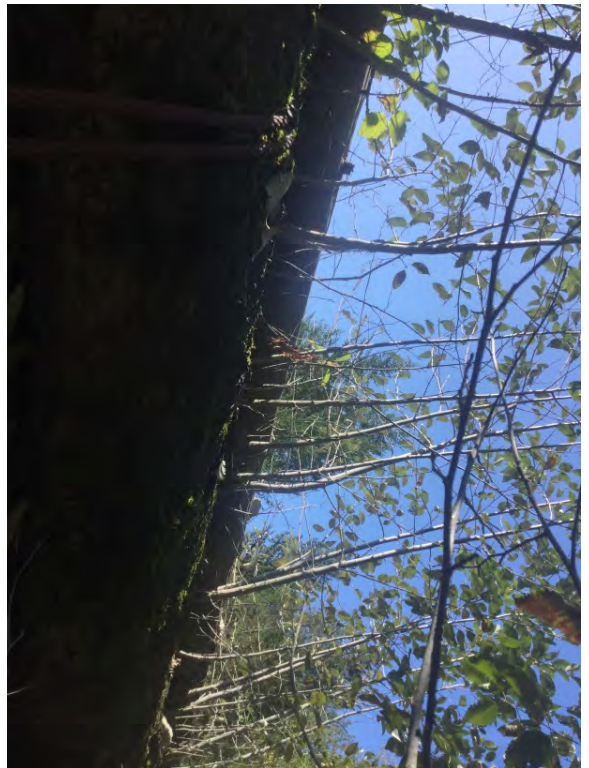
| Stringer<br>Number | Species | Peeled | Diameter<br>(mm) | Rot Depth<br>(mm) | Condition | Comment |
|---|---|---|---|---|---|---|
| 11 | Fd | | | 50 | | Cracked midspan |

Stringer 11 cracked

Old fir stringers with advanced rot. Stringers 10, 11, 12 have cracks midspan. Downrated to 5 tonnes. Replace.  
Update Sept 19, 2019: "Bridge closed" sign posted

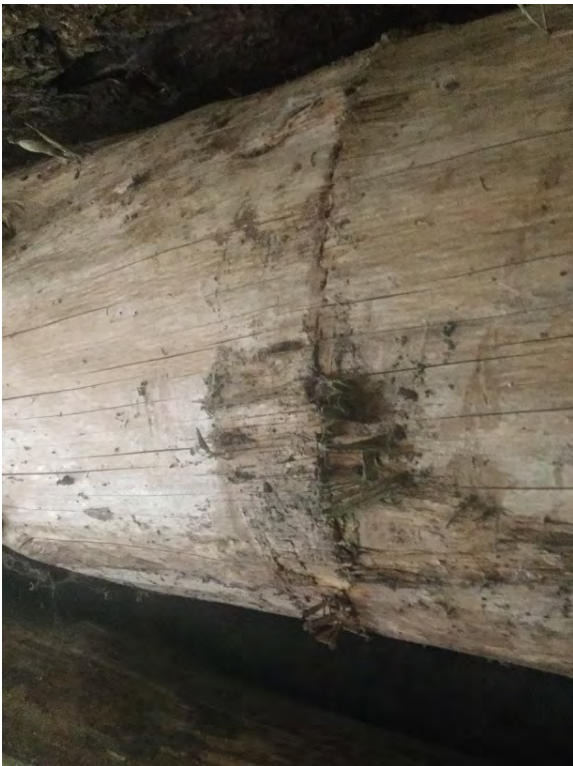
Stringer 12 - cracked midspan

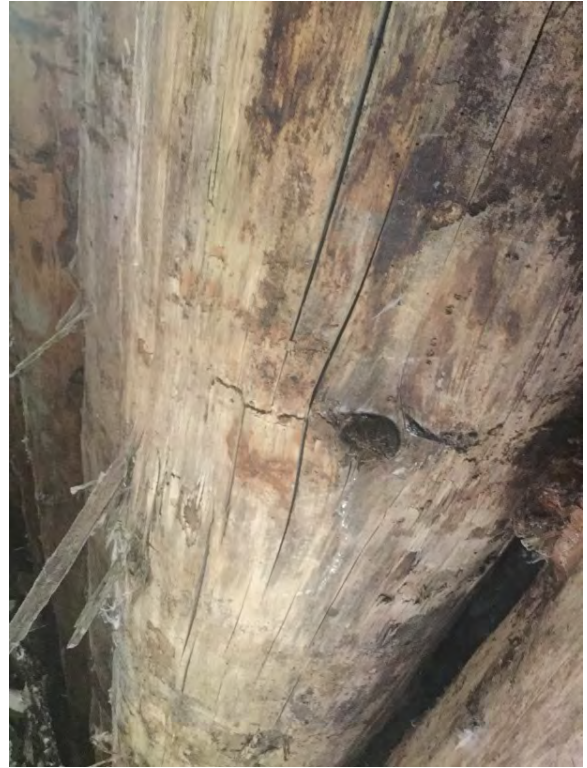
| Stringer<br>Number | Species | Peeled | Diameter<br>(mm) | Rot Depth<br>(mm) | Condition | Comment |
|---|---|---|---|---|---|---|
| 10 | Fd | | | 100 | | Cracked midspan |

Stringer 10 crack

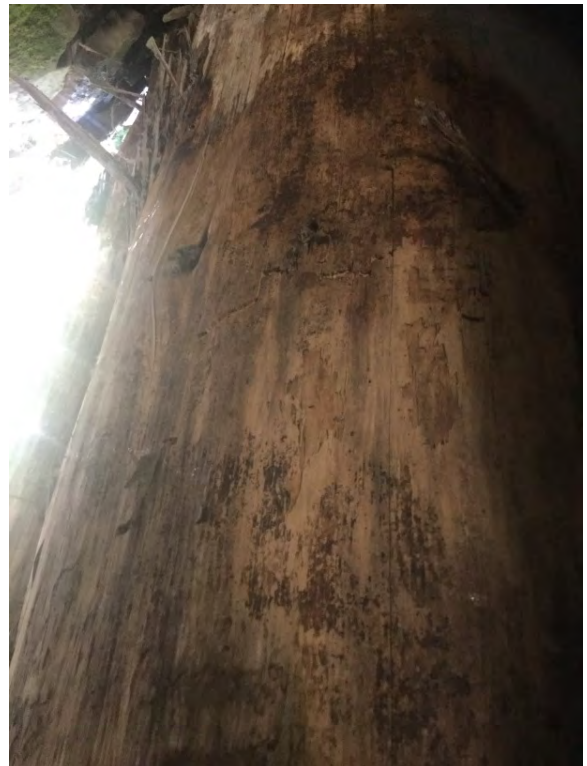
Stringer 10 crack
