SQ-3131

MAMQUAM 01 13.2km

2019 Inspection

| Crossing Name | Skookum Creek |

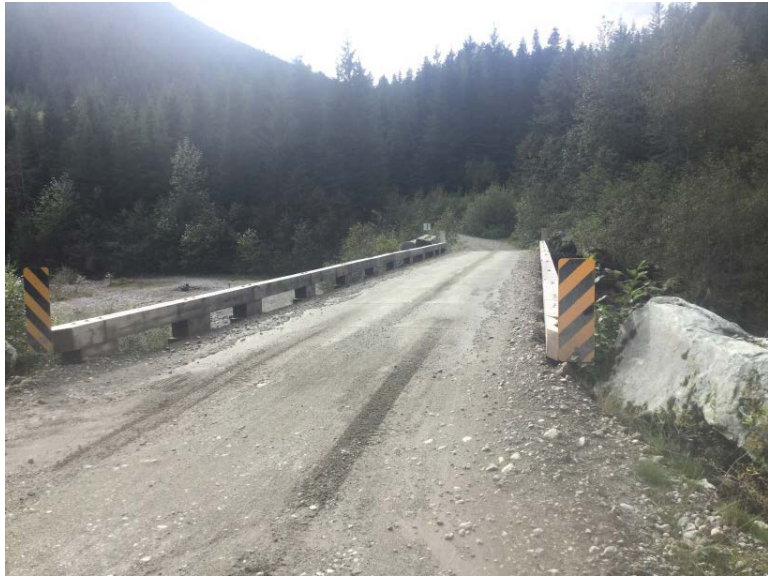
Approach from Left Bank when facing downstream

Pothole camp approach

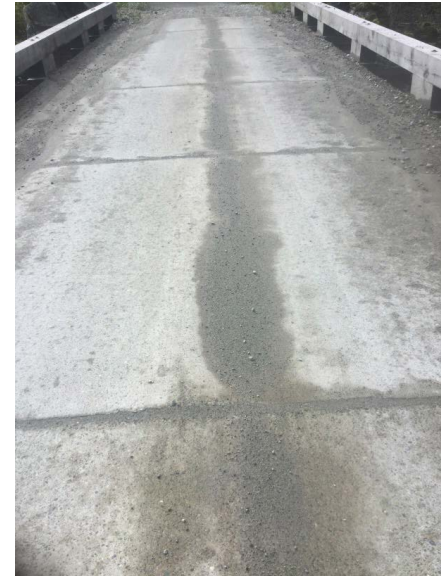
| Deck Joints | Fair | Not flush with deck |

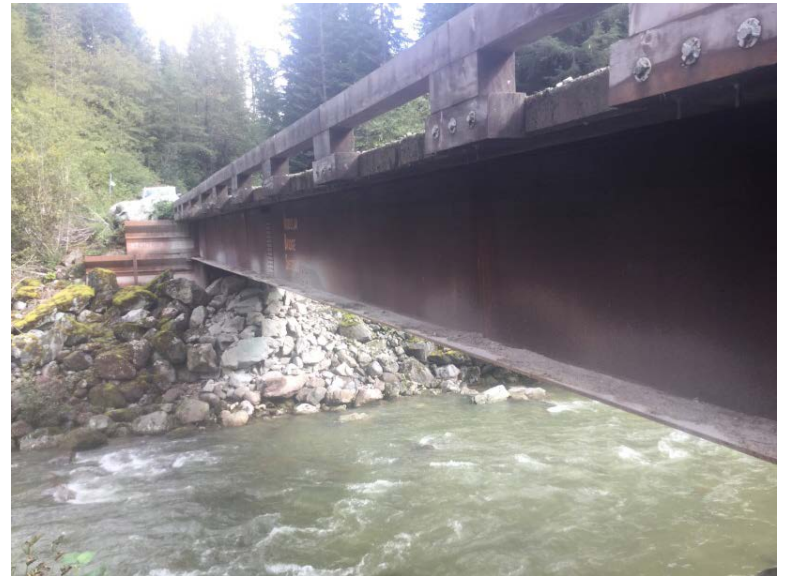
Upstream Profile

Minor rust scale, particularly upstream upper flange
