SQ-3132

MAMQUAM 01 10.5km

2019 Inspection

| Crossing Name | Raffuse Creek |

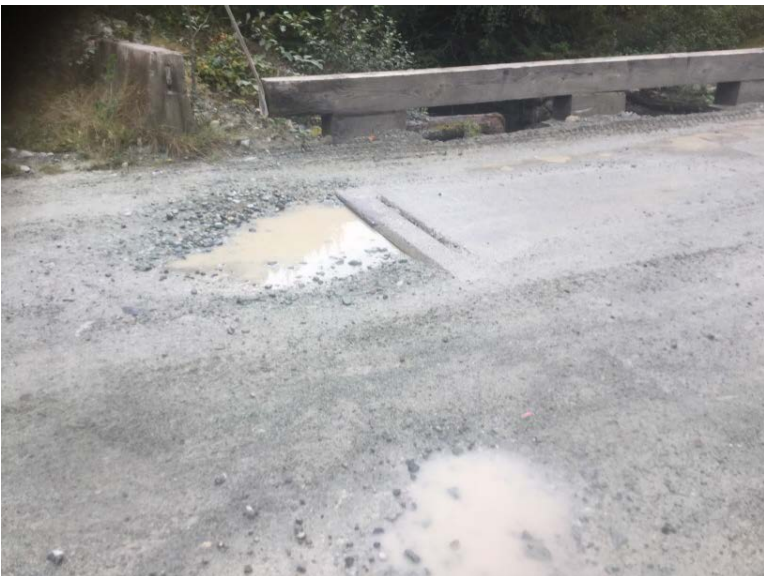
Pothole right approach

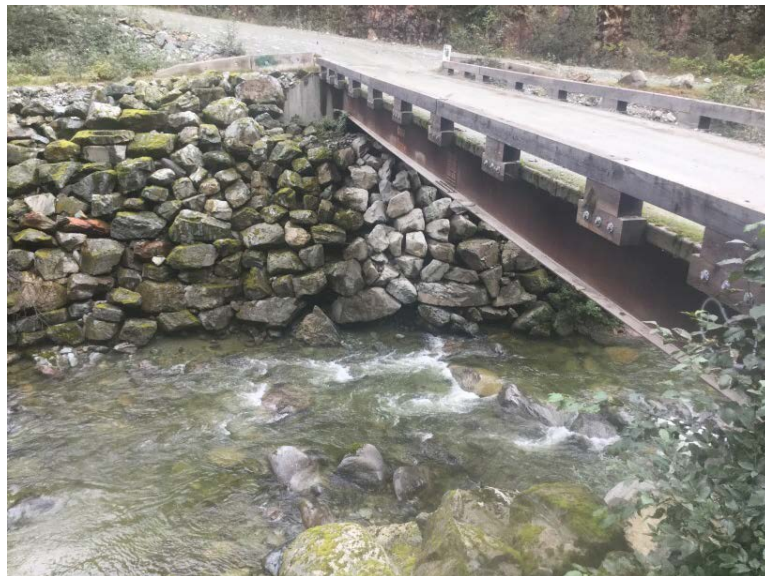
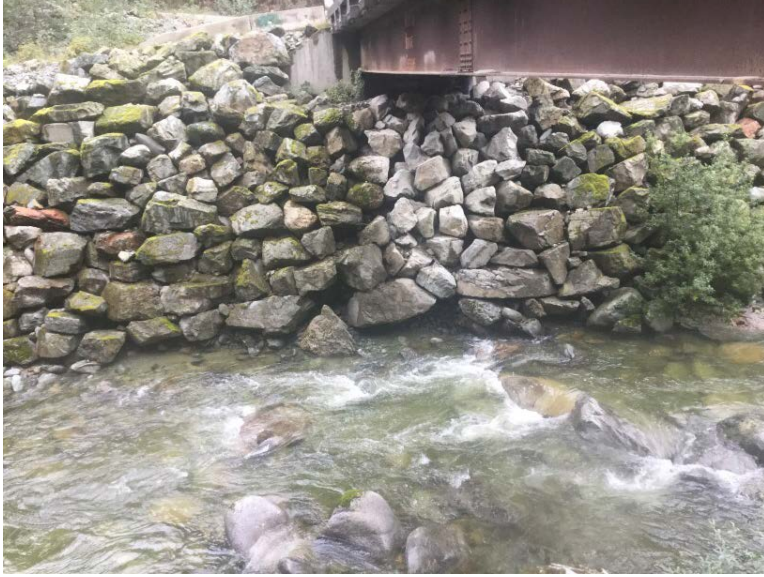
Right Bank Abutment when facing downstream

Larger riprap wall on right is undermined. Monitor.

Riprap Fair Scoured right abutment side

1 Monitor riprap
