SQ-3133

MAMQUAM 01 14.2km

2019 Inspection

| Structure Class | Major Culvert |

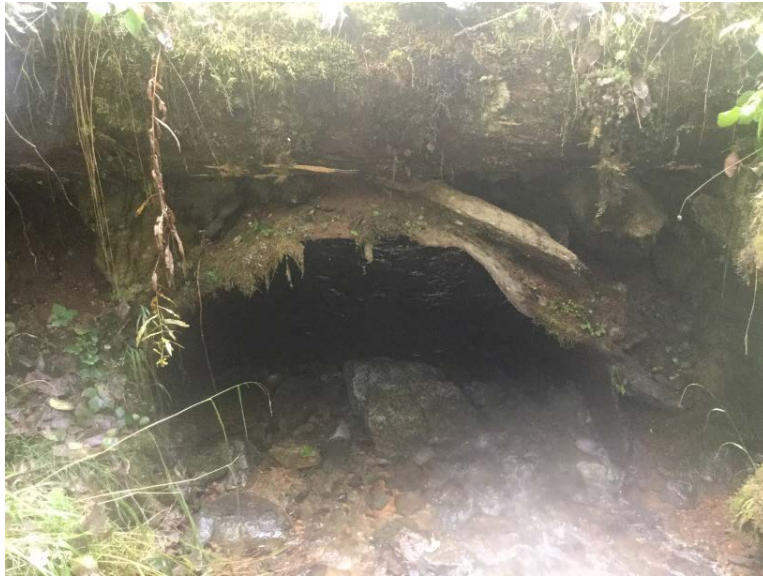
Inlet Good

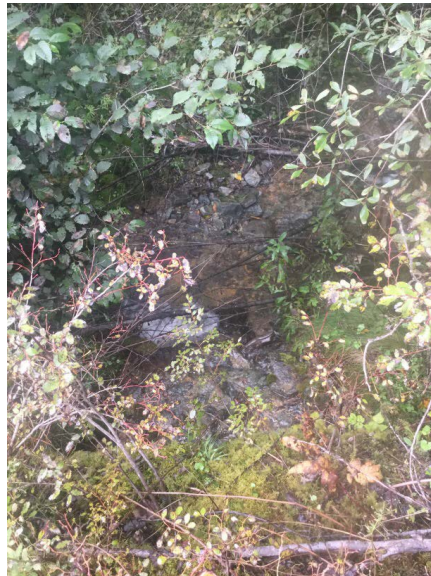
Outlet Good

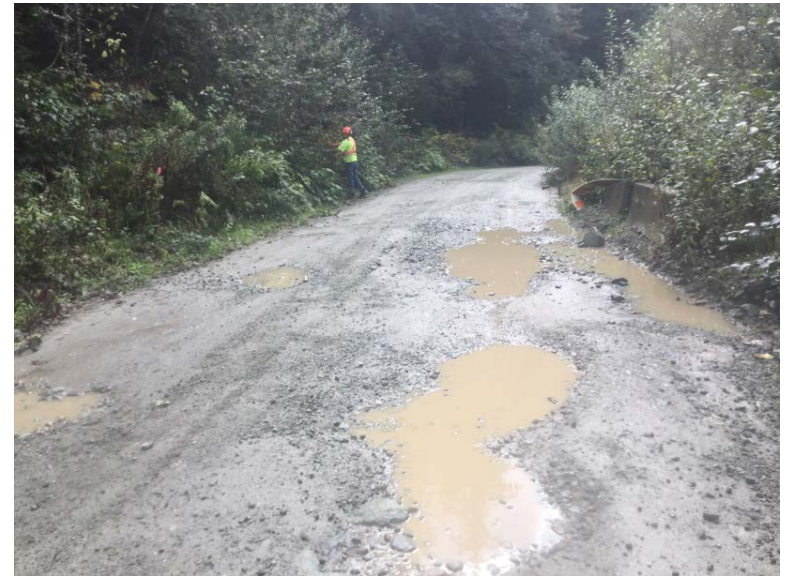
Approach from Right Bank when facing downstream

Alignment Good

Road Surface Good
