SQ-3135

MAMQUAM 01 19.2km

2019 Inspection

| Crossing Name | Martin Creek |

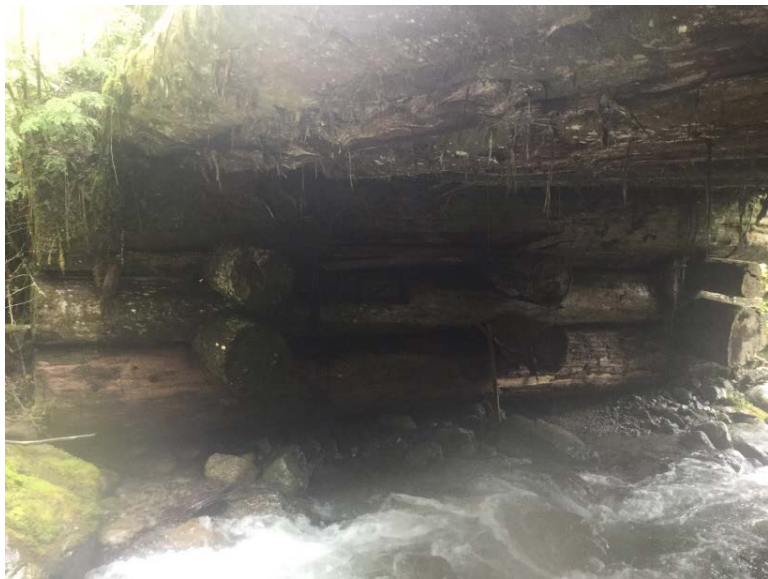
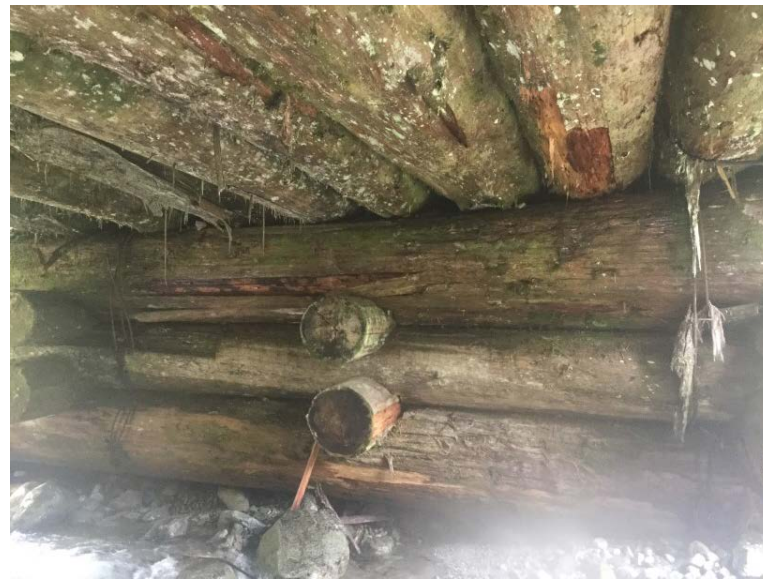
Left Bank Abutment when facing downstream

Older Cw log stringer bridge. Stringers in fair condition, small fruiting bodies on stringers (cedar). No heart rot detected. 3 log high crib scoured on left side. Consider replacement due to age, scour. Large puddle on deck.

Log/Timber Cribs Fair Old cribs, scoured left side. Monitor.

| Item | Monitor Description | Frequency |
|---|---|---|
| 1 | Monitor crib left for scour | Routine Inspection |

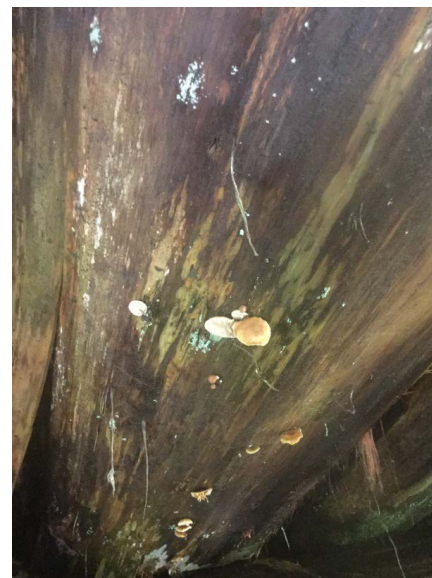
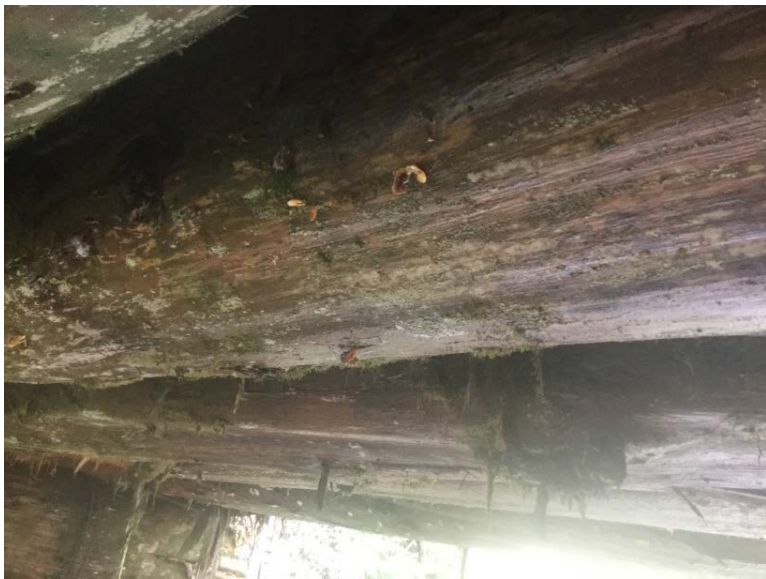
Stringers

| Stringer<br>Number | Species | Peeled | Diameter<br>(mm) | Rot Depth<br>(mm) | Condition | Comment |
|---|---|---|---|---|---|---|
| 1 | Cw | Y | | 40 | | Small fruiting bodies |
| 3 | Cw | Y | | 50 | | Small fruiting bodies |
| 6 | Cw | Y | | 40 | | Small fruiting bodies |

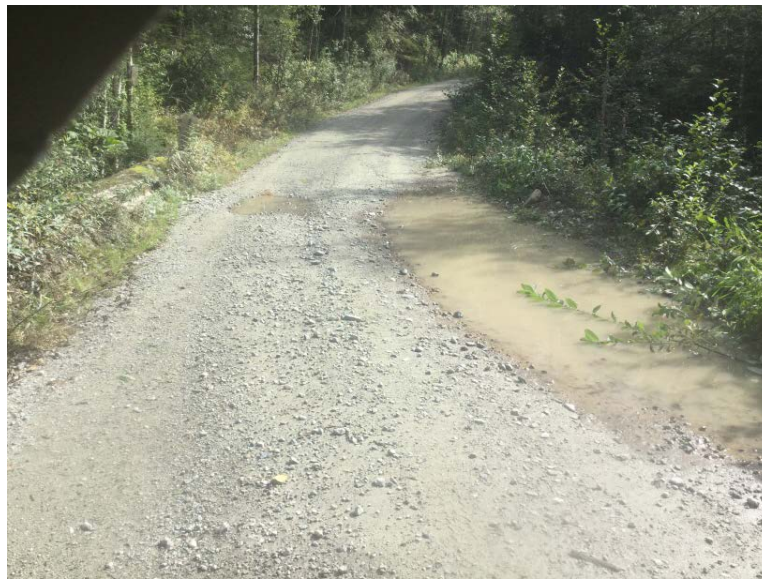
| Gravel Surface | Poor | Large pothole |
| Overall Deck Condition | Poor | No guardrail |

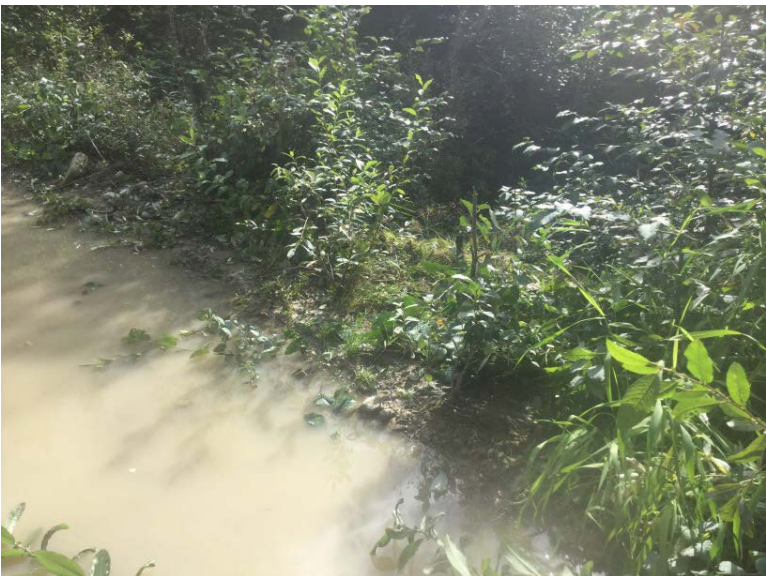
Guard Rail

| Curb Rail/Blocks/Posts | Poor | Missing on ds side |

| 1 | High | Add guardrail downstream side |
