SQ-3149

BRITANNIA 01 2.5km

2019 Inspection

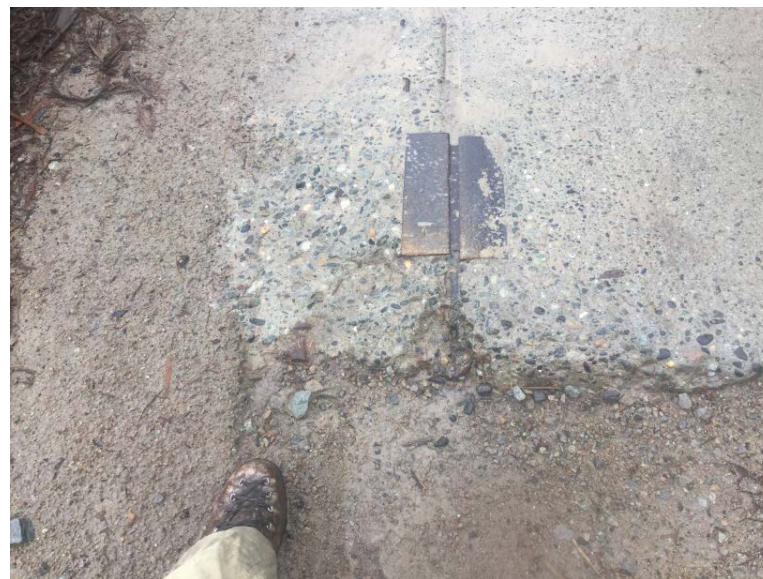
Concrete Deck Fair Damaged on camp side. Repair.

| Repair Item | Priority | Repair Description |
|---|---|---|
| 2 | Medium | Repair concrete deck |

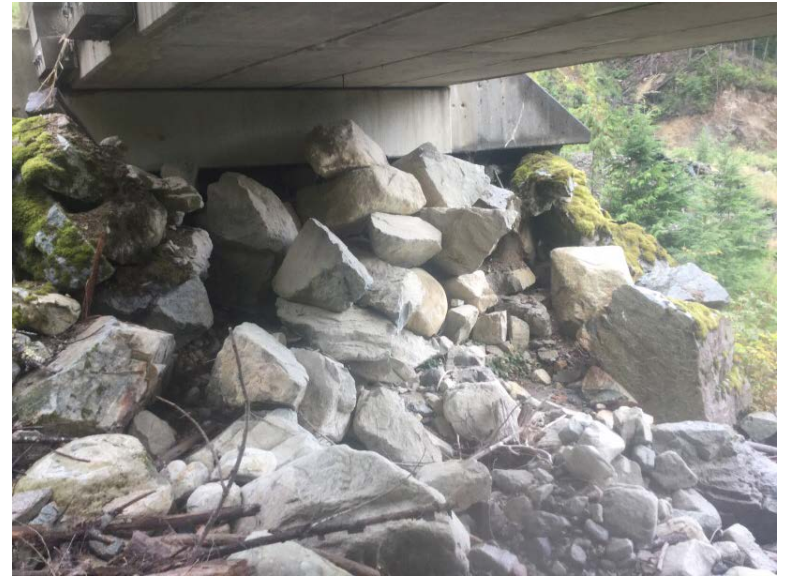
Left Bank Abutment when facing downstream

Riprap Poor Scoured both sides.

| Repair Item | Priority | Repair Description |
|---|---|---|
| 1 | Medium | Repair riprap |
