SQ-3151

BRITANNIA 01 2.9km

2019 Inspection

| Structure Class | Major Culvert |

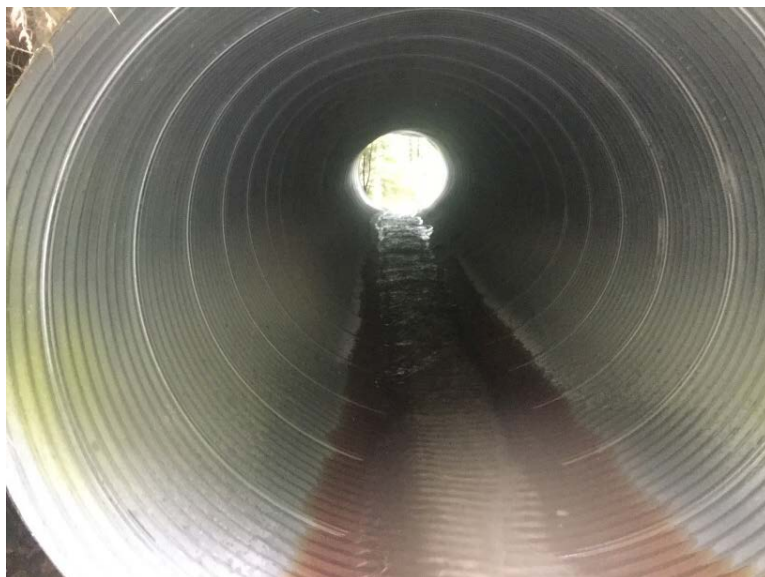
| Inlet | Good | |

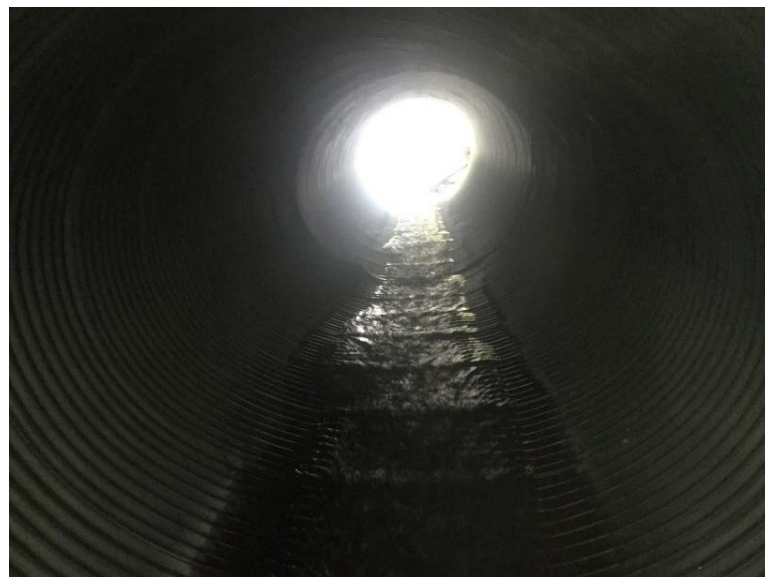
| Outlet | Good | |

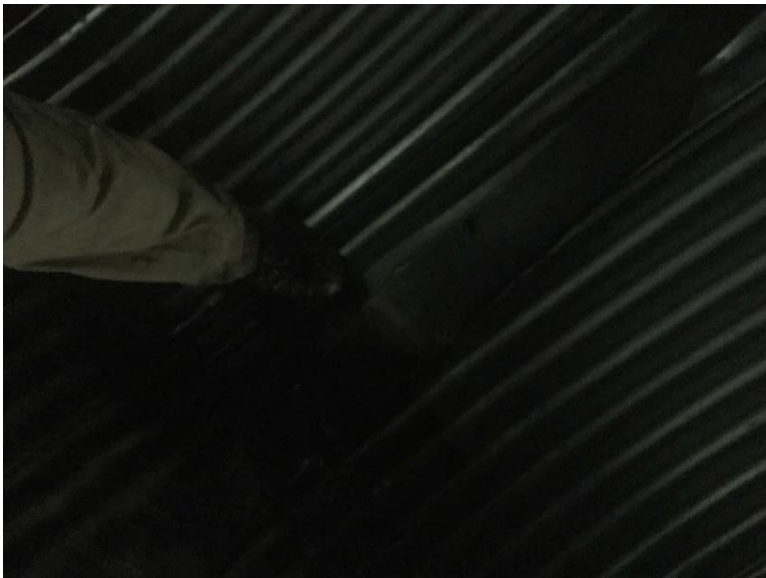
Connection

| Coupled Connections | Fair | Approx 6" gap |
