SQ-3153

BRITANNIA 01 6.9km

2019 Inspection

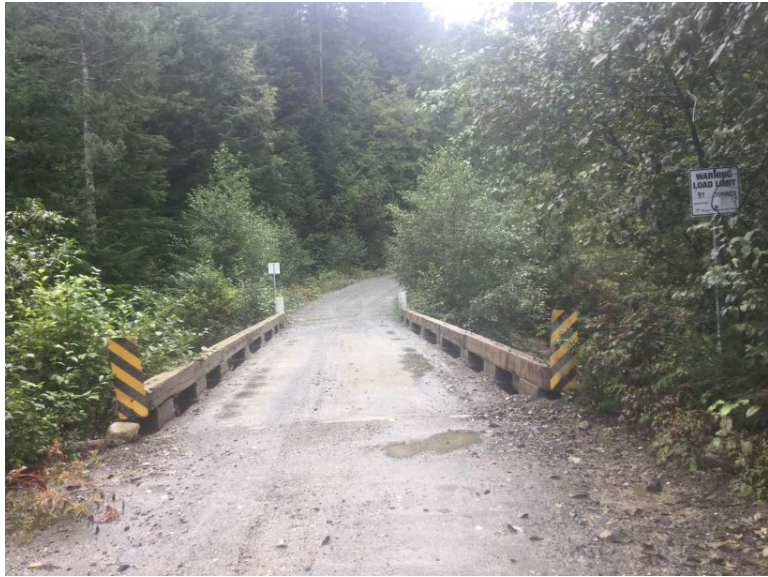
Approach from Left Bank when facing downstream

Fender Condition Poor 2 missing

| 1 | Medium | Add approach barriers |

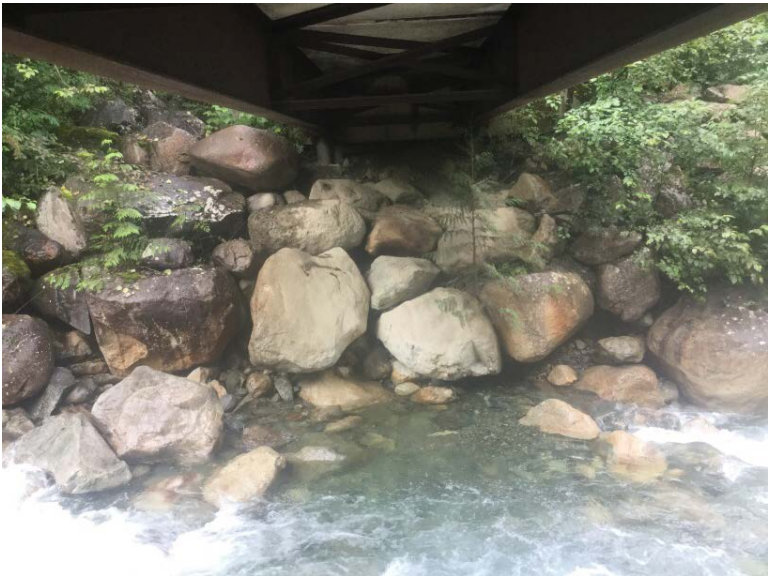
Left Bank Abutment when facing downstream

Riprap Fair Erosion under bottom of riprap on left.

| Item | Monitor Description | Frequency |
|---|---|---|
| 1 | Monitor scour left abutment | Anually |
