SQ-3178

MILLER BENCH 01 1.9km

2019 Inspection

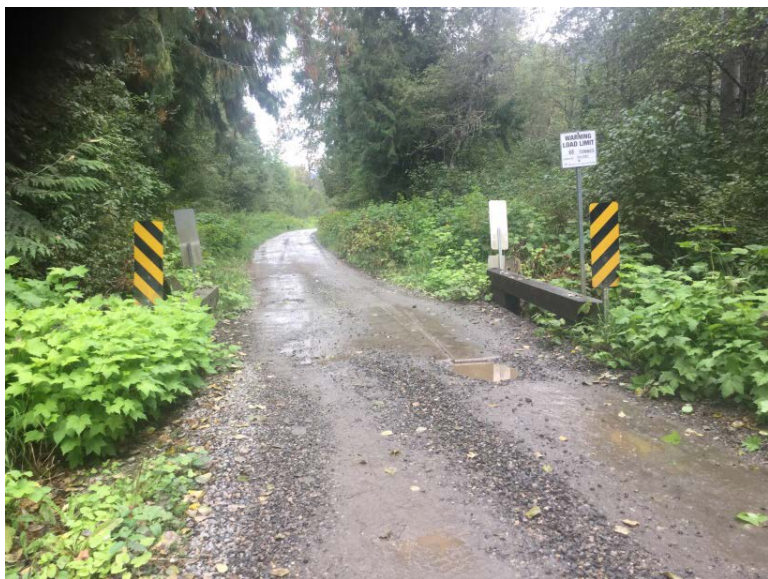
Approach from Right Bank when facing downstream

Road Surface Fair Potholes at approach

| Repair | | Repair Description |
|---|---|---|
| 3 | Low | Fill pothole at approach |

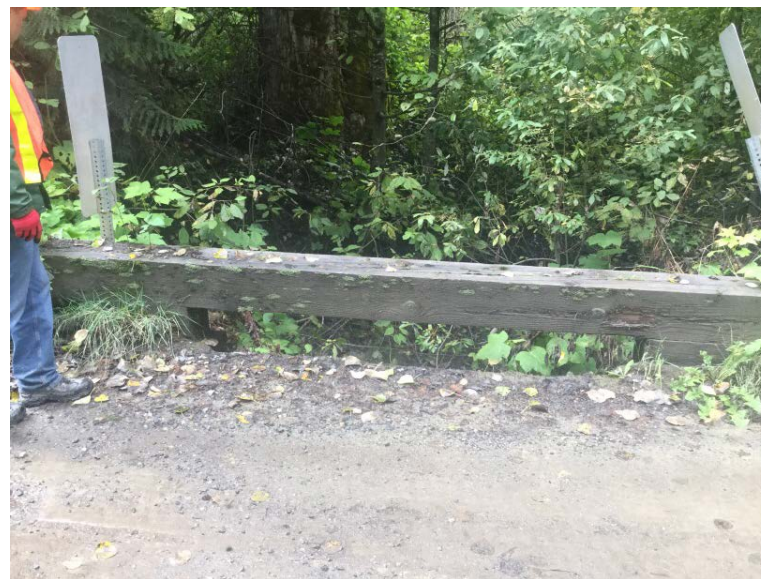
Guard Rail

| Curb Rail/Blocks/Posts | Poor | Upstream guardrail rotten |

| Repair | | Repair Description |
|---|---|---|
| 1 | High | Replace upstream side guardrail. Downstream side ok. |

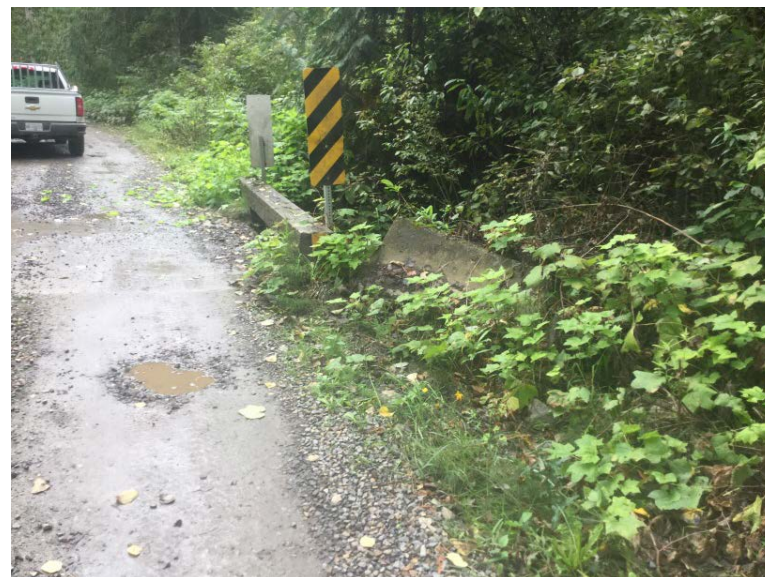
Approach Barrier

Fender Condition Poor No post mis-aligned.

| Repair | | Repair Description |
|---|---|---|
| 2 | High | Re- set no post barriers |
