SQ-3180

MILLER BENCH 01 2.6km

2019 Inspection

| Crossing Name | Trib to Ryan River |

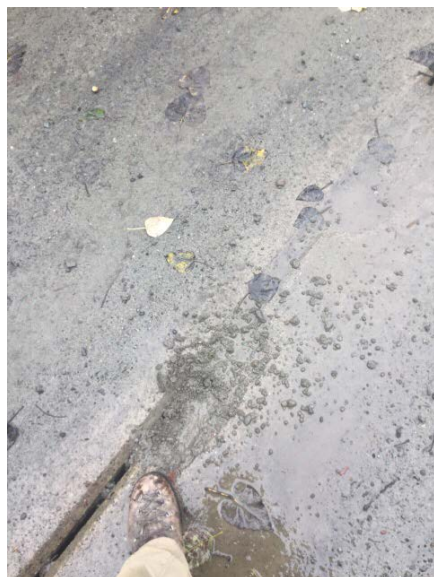
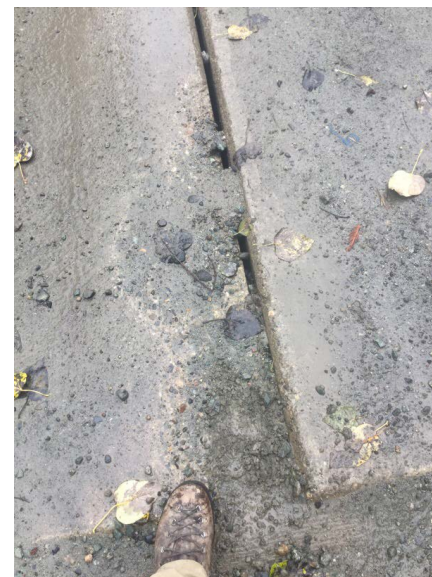
2 small damaged sections. No rebar showing. Repair.

| Concrete Deck | Fair | Small damaged section |

| 1 | Medium | Repair concrete deck |
